# 18 PRESERVATION BRIEFS

## Rehabilitating Interiors in Historic Buildings

### Identifying and Preserving Character-defining Elements

U.S. Department of the Interior  
National Park Service  
Cultural Resources  
Heritage Preservation Services

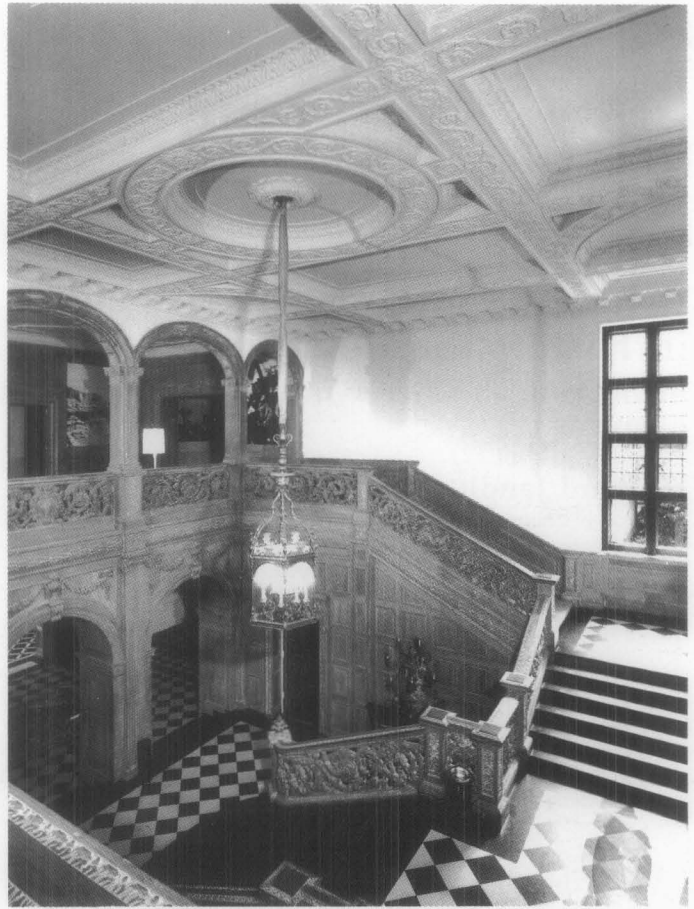
Figure 1. This architect-designed interior reflects early 20th-century American taste: the checkerboard tile floor, wood wainscot, coffered ceiling, and open staircase are richly detailed and crafted by hand. Not only are the individual architectural features worthy of preservation, but the planned sequence of spaces—entry hall, stairs, stair landings, and loggia—imparts a grandeur that is characteristic of high style residences of this period. This interior is of Greystone, Los Angeles, California. Photography for HABS by Jack E. Boucher

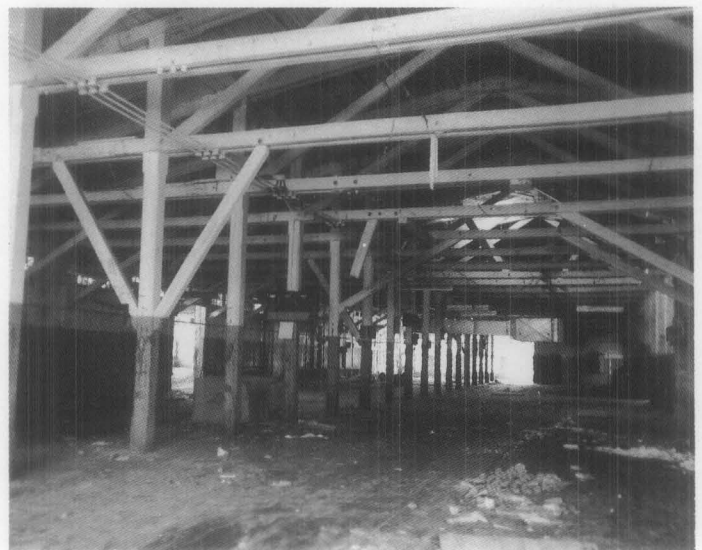
Figure 2. The interiors of mills and industrial buildings frequently are open, unadorned spaces with exposed structural elements. While the new uses to which this space could be put are many—retail, residential, or office—the generous floor-to-ceiling height and exposed truss system are important character-defining features and should be retained in the process of rehabilitation.

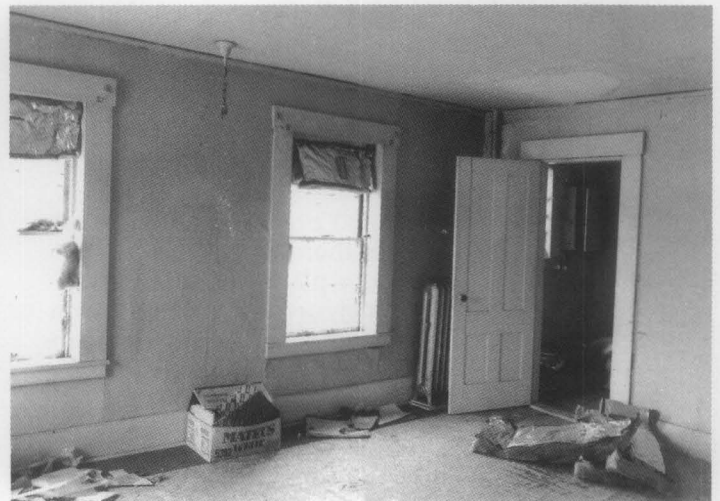
Figure 5. The interior of a simply detailed worker's house of the 19th century may be as important historically as the richly ornamented interior seen in figure 1. Although the interior of this house has not been properly maintained, the wide baseboards, flat window trim, and four-panel door are characteristic of workers' housing during this period and deserve retention during rehabilitation.

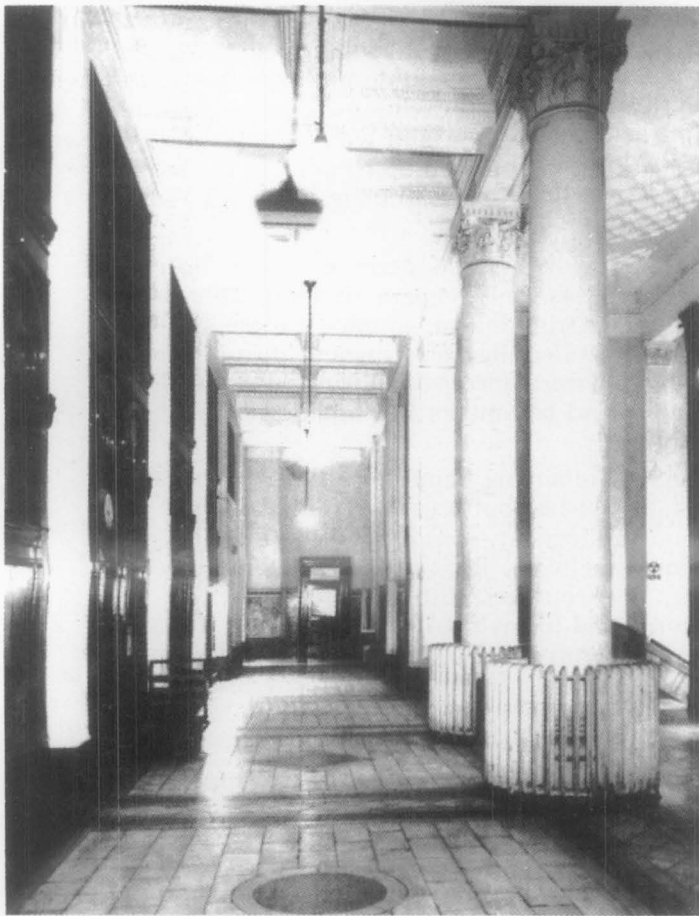
Figure 9. The tangible reminders of early mechanical systems can be worth saving. In this example, in the Old Post Office in Washington, D.C., radiators encircle Corinthian columns in a decorative manner. Note, too, the period light fixtures. These features were retained when the building was rehabilitated as retail and office space. Photo: Historic American Buildings Survey

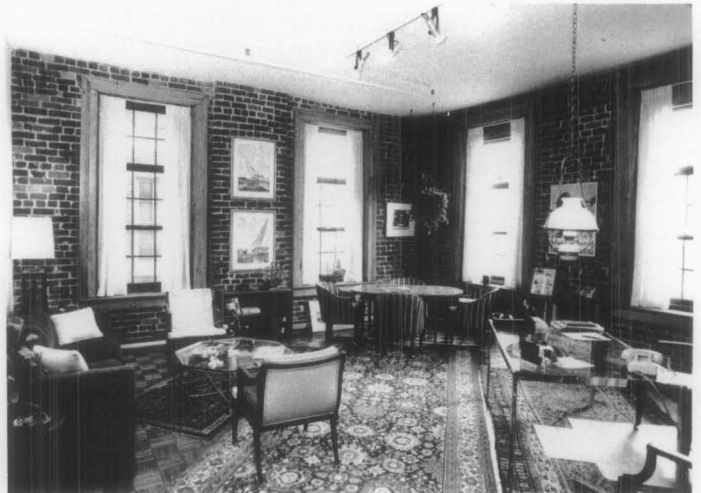
Figure 10. In this case plaster has been removed from perimeter walls, leaving brick exposed. In removing finishes from historic masonry walls, not only is there a loss of historic finish, but raw, unfinished walls are exposed, giving the interior an appearance it never had. Here, the exposed brick is of poor quality and the mortar joints are wide and badly struck. Plaster should have been retained and repaired, as necessary.

9. Avoid removing paint and plaster from traditionally finished surfaces, to expose masonry and wood. Conversely, avoid painting previously unpainted millwork. Repairing deteriorated plasterwork is encouraged. If the plaster is too deteriorated to save, and the walls and ceilings are not highly ornamented, gypsum board may be an acceptable replacement material. The use of paint colors appropriate to the period of the building's construction is encouraged.

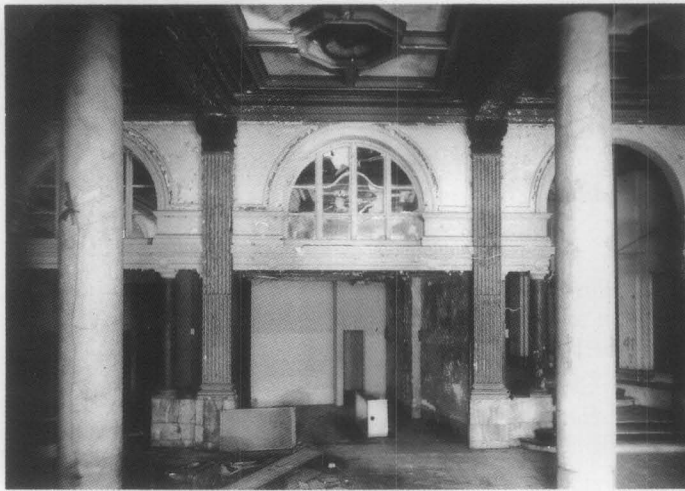
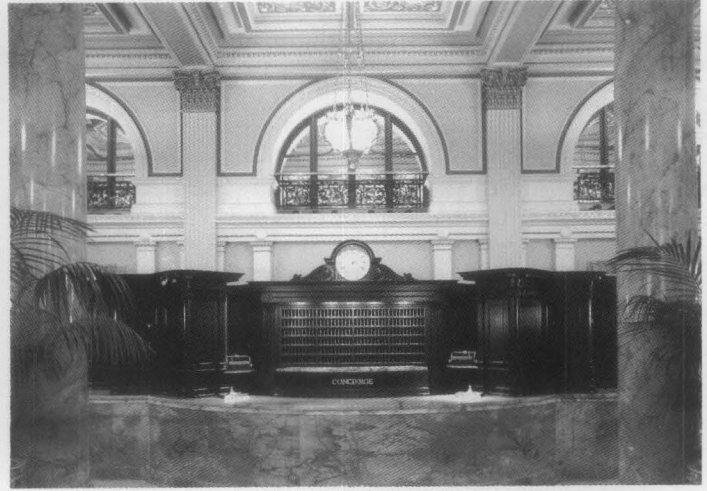
Figure 11. These dramatic “before” and “after” photographs show a severely deteriorated space restored to its original elegance: plaster has been repaired and painted, the scagliola columns have been restored to match marble using traditional craft techniques, and missing decorative metalwork has been re-installed in front of the windows. Although some reorganization of the space took place, notably the relocation of the front desk, the overall historic character of the space has been preserved. These views are of the lobby in the Willard Hotel, Washington, D.C. Credit: Commercial Photographers (left); Carol M. Highsmith (right)

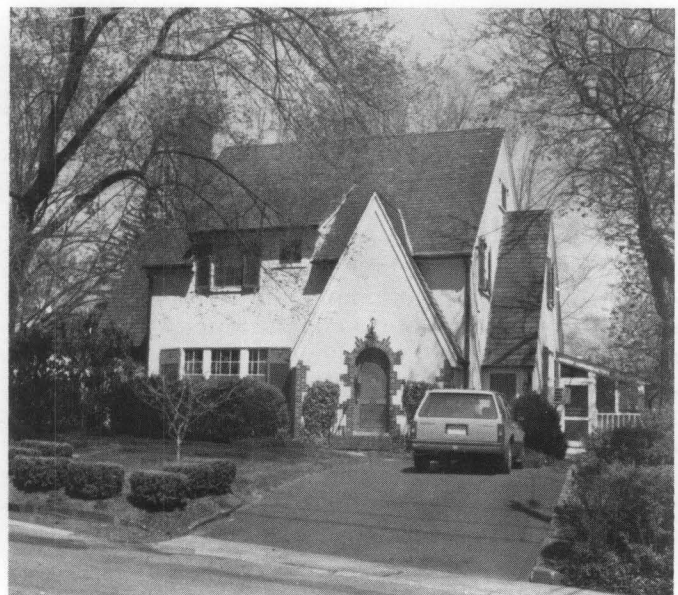
Fig. 1. These two houses in a residential section of Winchester, Virginia, illustrate the continuing popularity of stucco (a) from this early 19th century, Federal style house on the left, (b) to Arts and Crafts style cottage that was built across the street in the 1930's. Photos: Anne Grimmer.

Stucco has been used since ancient times. Still widely used throughout the world, it is one of the most common of traditional building materials (Fig. 1). Up until

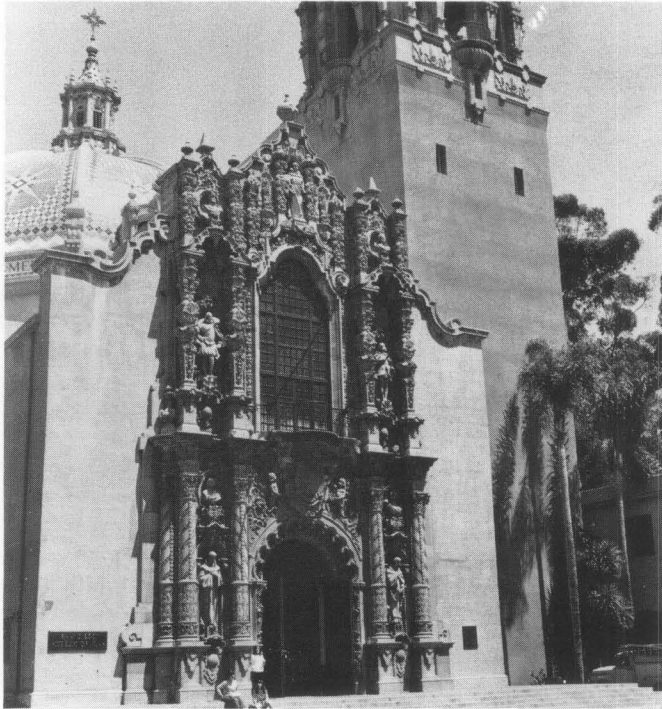
Fig. 4. The elaborate Spanish Colonial Revival style of this building designed by Bertram Goodhue for the 1915 Panama California Exposition held in San Diego's Balboa Park emphasizes the sculptural possibilities of stucco. Photo: C.W. Snell, National Historic Landmark Files.

The introduction of the many revival styles of architecture around the turn of the twentieth century, combined with the improvement and increased availability of portland cement resulted in a "craze" for stucco as a building material in the United States. Beginning about 1890 and gaining momentum into the 1930's and 1940's, stucco was associated with certain historic architectural styles, including: Prairie; Art Deco, and Art Moderne; Spanish Colonial, Mission, Pueblo, Mediterranean, English Cotswold Cottage, and Tudor Revival styles; as well as the ubiquitous bungalow and "four-square" house (Fig. 3). The fad for Spanish Colonial Revival, and other variations on this theme, was especially important in furthering stucco as a building material in the United States during this period, since stucco clearly looked like adobe (Fig. 4).

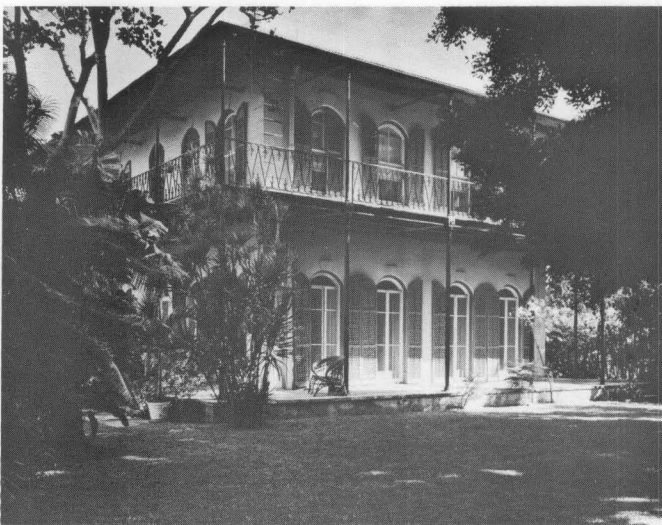
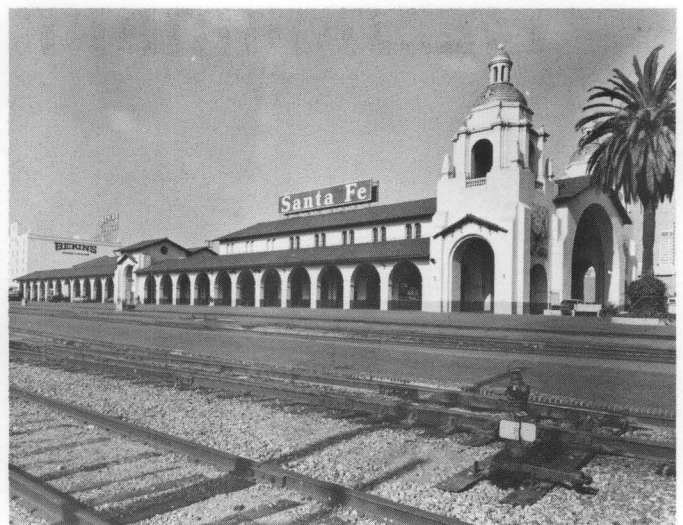
Fig. 5. During the 19th and 20th centuries stucco has been a popular material not only for residential, but also for commercial buildings in the Spanish style. Two such examples are (a) the 1851 Ernest Hemingway House, Key West, Florida, built of stuccoed limestone in a Spanish Caribbean style; and (b) the Santa Fe Depot (Union Station), San Diego, California, designed by the architects Bakewell and Brown in 1914 in a Spanish Colonial Revival style, and constructed of stucco over brick and hollow tile. Photos: (a) J.F. Brooks, HABS Collection, (b) Marvin Rand, HABS Collection.

of the "romance" of period styles, and adopted the stucco construction that had become synonymous with these styles (Fig. 5).

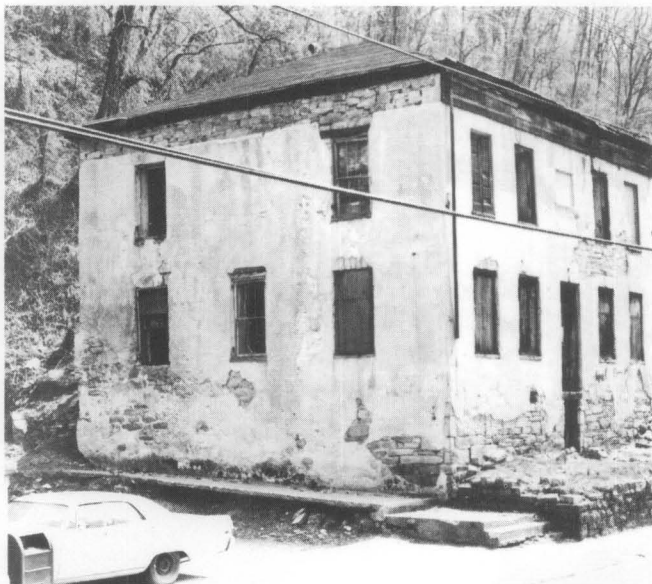
Fig. 7. Patches of stucco have fallen off this derelict 19th century structure exposing the rough-cut local stone substrate. The missing wood entablature on the side and the rough wood lintel now exposed above a second-floor window, offer clues that the building was stuccoed originally. Photo: National Park Service Files.

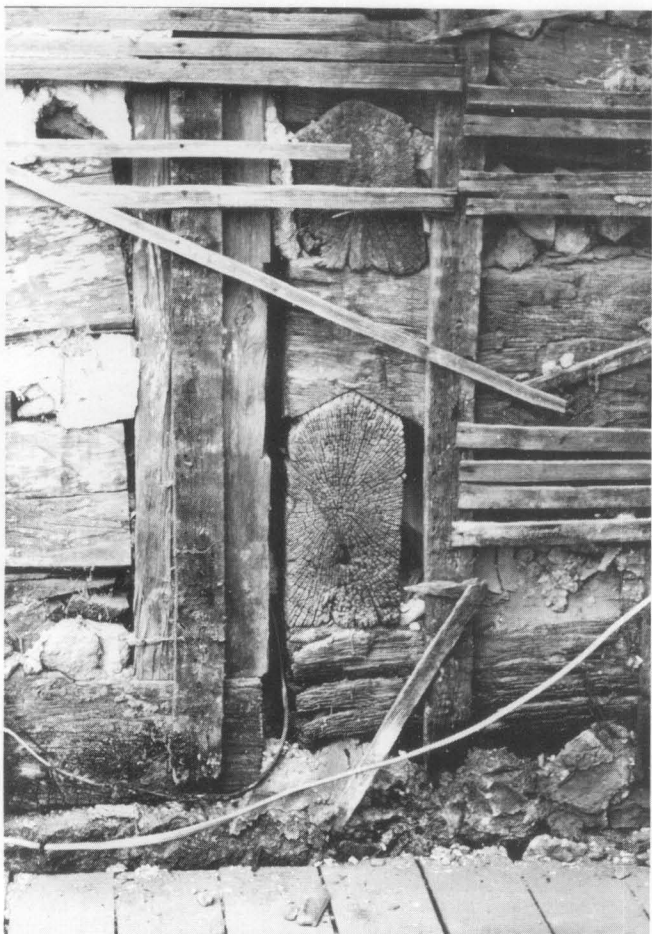
Fig. 8. Removal of deteriorated stucco in preparation for stucco repair on this late-18th century log house in Middleway, West Virginia, reveals that the stucco was applied to hand-riven wood lath nailed over vertical wood strips attached to the logs. Photo: Anne Grimmer.

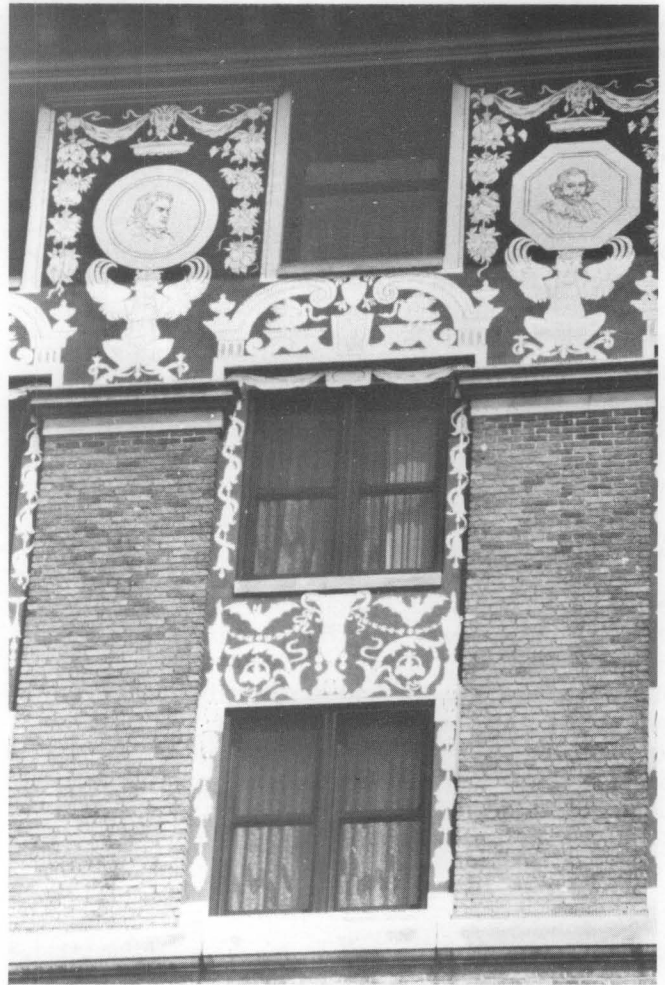
Fig. 11. The Hotel Washington, Washington, D.C. (1916–1917), is notable for its decorative *sgraffito* surfaces. Stucco panels under the cornice and around the windows feature classical designs created by artists who incised the patterns in the outer layer of red-colored stucco while still soft, thereby exposing a stucco undercoat of a contrasting color. Photo: Kaye Ellen Simonson.

Until the early-twentieth century when a variety of novelty finishes or textures were introduced, the last coat of stucco was commonly given a smooth, troweled finish, and then scored or lined in imitation of ashlar. The illusion of masonry joints was sometimes enhanced by a thin line of white lime putty, graphite, or some other pigment. Some nineteenth century buildings feature a water table or raised foundation of rough-cast stucco that differentiates it from the stucco surface above, which is smooth and scored (Fig. 10). Other novelty or textured finishes associated with the "period" or revival styles of the early-twentieth century include: the English cottage finish, adobe and Spanish, pebble-dashed or dry-dash surface, fan and sponge texture, reticulated and vermiculated, roughcast (or wet dash), and sgraffito (Fig. 11).

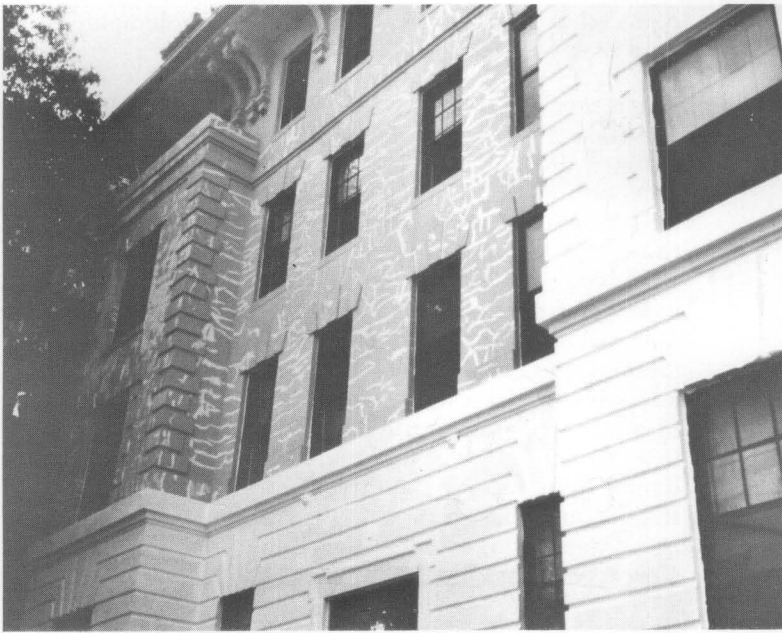
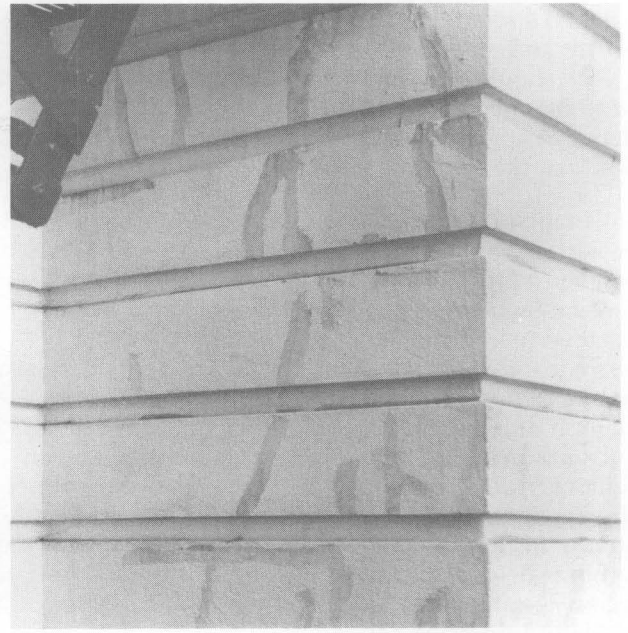
Fig. 13. (a) In preparation for repainting, hairline cracks on this Mediterranean style stucco apartment building were filled with a commercial caulking compound; (b) dirt is attracted and adheres to the texture of the caulked areas, and a year after painting, these inappropriate repairs are highly obvious. Photos: Anne Grimmer.

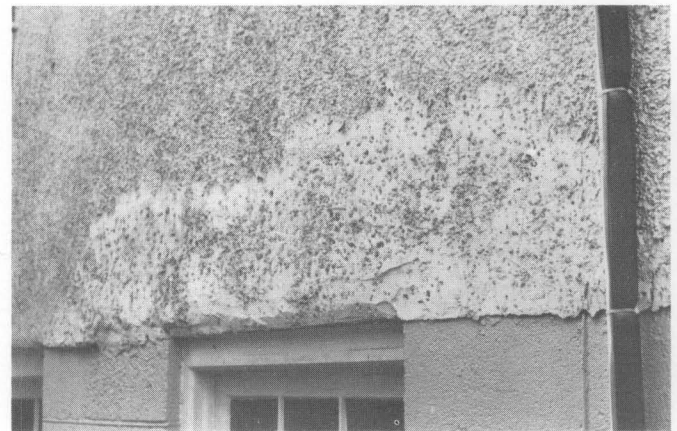
Fig. 14. This poorly executed patch is not the work of a professional plasterer. While it may serve to keep out water, it does not match the original surface, and is not an appropriate repair for historic stucco. Photo: Betsy Chittenden.

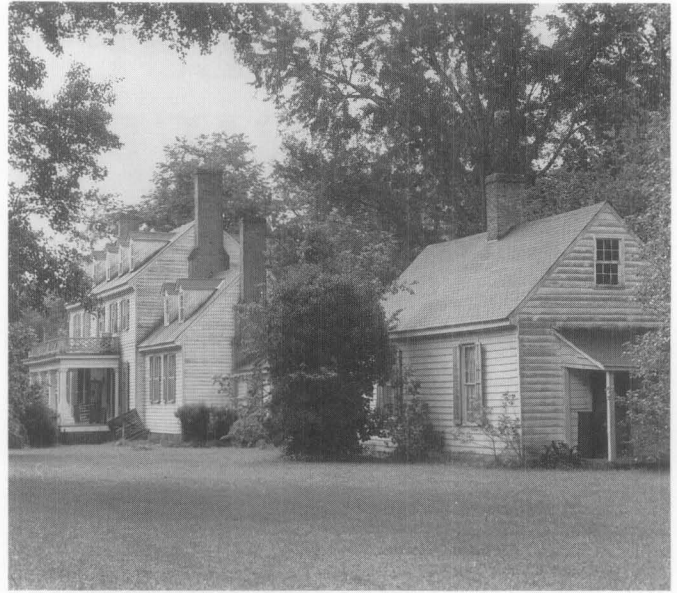
1. Eighteenth century and later vernacular architecture depended on the siting of the building, deciduous trees, cross ventilation, and the placement of windows and chimneys to maximize winter heating and natural summer cooling. Regional details, as seen in this Virginia house, include external chimneys and a separate summer kitchen to reduce fire risk and isolate heat in the summer. Photo: NPS Files.

**Eighteenth Century.** Early heating and ventilation in America relied upon common sense methods of *managing the environment* (see figure 1). Builders purposely sited houses to capture winter sun and prevailing summer cross breezes; they chose materials that could help protect the inhabitants from the elements, and took precautions against precipitation and damaging drainage patterns. The location and sizes of windows, doors, porches, and the floor plan itself often evolved to maximize ventilation. Heating was primarily from fireplaces or stoves and, therefore, was at the source of delivery. In 1744, Benjamin Franklin designed his “Pennsylvania stove” with a fresh air intake in order to maximize the heat radiated into the room and to minimize annoying smoke.

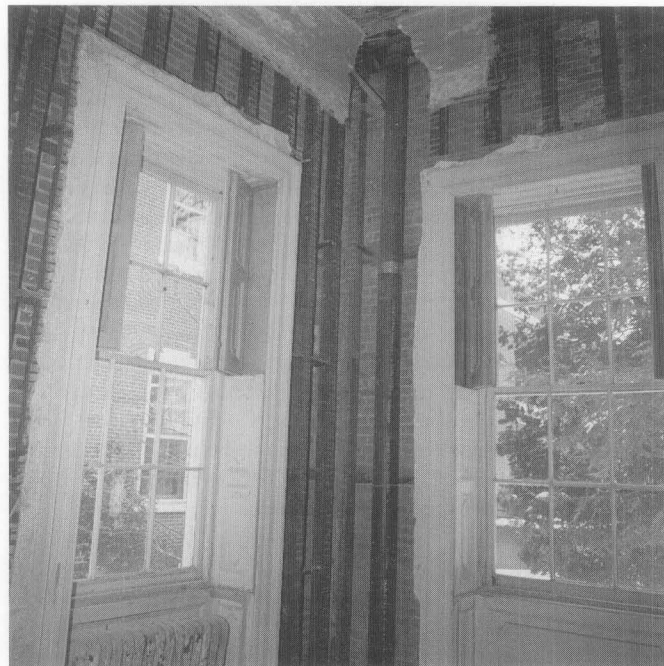
5. The installation of vapor retarders in walls of historic buildings in an effort to contain interior moisture can cause serious damage to historic finishes as shown here. In this example, all the wall plaster and lath have been stripped in preparation for a vapor barrier prior to replastering. Controlling interior temperature and relative humidity can be more effective than adding insulation and vapor barriers to historic perimeter walls. Photo: Ernest A. Conrad, P.E.

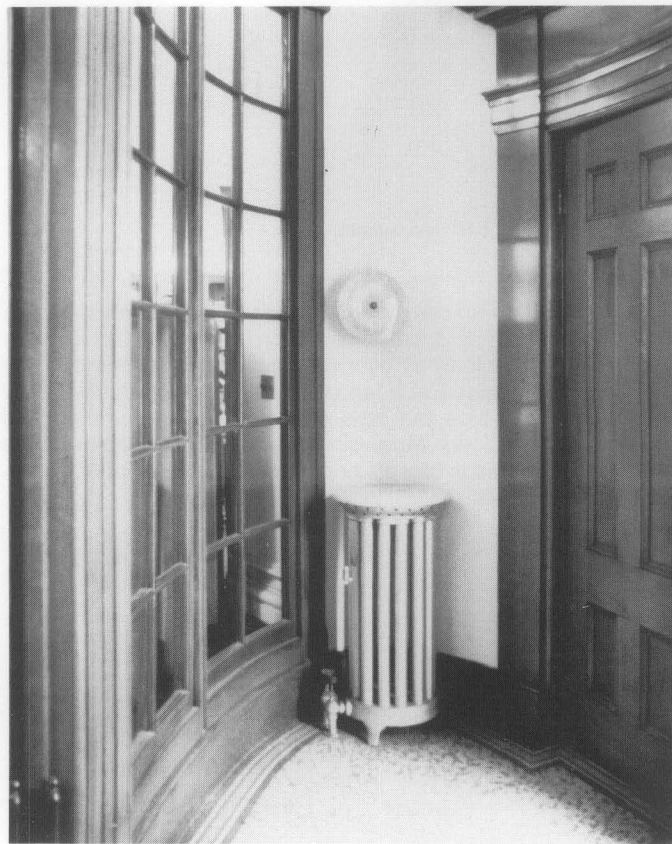
6. A condition assessment during the planning stage would identify this round radiator in a small oval-shaped vestibule as a significant element of the historic heating system. In upgrading the mechanical system, the radiator should be retained. Photo: Michael C. Henry, P.E., AIA.

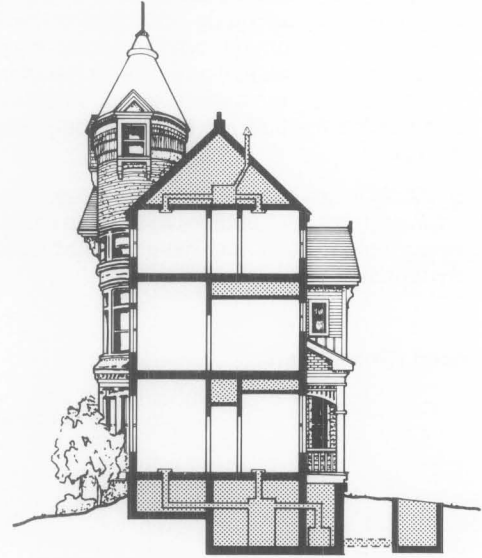
8. In considering options for new systems, existing spaces should be evaluated for their ability to house new equipment. This sketch shows several areas where new mechanical equipment could be located to avoid damaging significant spaces. Sketch: NPS files

4. **Prioritize architecturally significant spaces, finishes, and features to be preserved.** Significant architectural spaces, finishes and features should be identified and evaluated at the outset to ensure their preservation. This includes significant existing mechanical systems or elements such as hot water radiators, decorative grilles, elaborate switchplates, and non-mechanical architectural features such as cupolas, transoms, or porches. Identify non-significant spaces where mechanical equipment can be placed and secondary spaces where equipment and distribution runs on both a horizontal and vertical basis can be located. Appropriate secondary spaces for housing equipment might include attics, basements, penthouses, mezzanines, false ceiling or floor cavities, vertical chases, stair towers, closets, or exterior below-grade vaults (see figure 8).

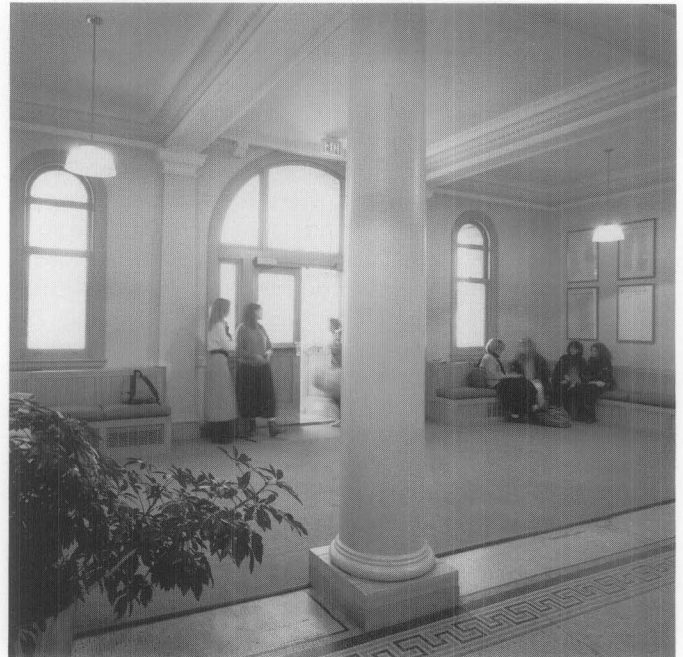
a. Before and after of a circa 1900 school entrance. The radiators have been replaced with a two-pipe fan coil system built into bench seats. The ceiling was preserved and no exposed elements were required to add air conditioning. Piping runs are under the benches and there was no damage to the masonry walls. Photos: Notter Finegold + Alexander Inc. and Lautman Photography, Washington.

In designing a system, it is important to anticipate how it will be installed, how damage to historic materials can be minimized, and how visible the new mechanical system will be within the restored or rehabilitated spaces (see figure 10 a-f). Mechanical equipment space needs are often overwhelming; in some cases, it may be advantageous to look for locations outside of the building, including ground vaults, to house some of the equipment but only if there is no adverse impact to the historic landscape or adjacent archeological resources. Various means for reducing the heating and cooling loads (and thereby the size of the equipment) should be investigated. This might mean reducing slightly the comfort levels of the interior, increasing the number of climate control zones, or improving the energy efficiency of the building.

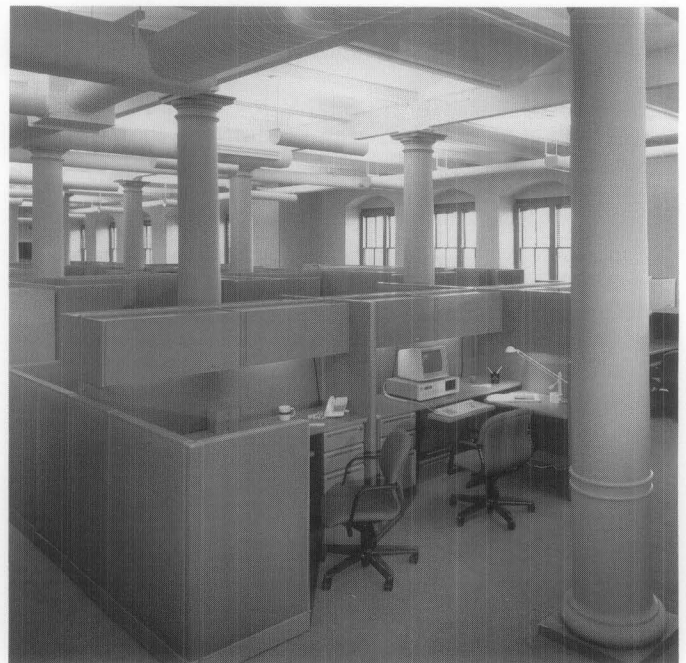
after

d. Auditors Buildings, Washington, D.C. This upper floor workspace had been modified over the years with dropped ceilings and partitions. In the recent restoration, the open plan workspace was restored, the false ceiling was removed, and the fireproof construction was exposed. A variable air volume (VAV) system using round double shell exposed ductwork is in keeping with the industrial character of the architectural space. Photo: Kenneth Wyner Photography, courtesy of Notter Finegold + Alexander Inc. Before view provided by Notter Finegold + Alexander/Mariani.

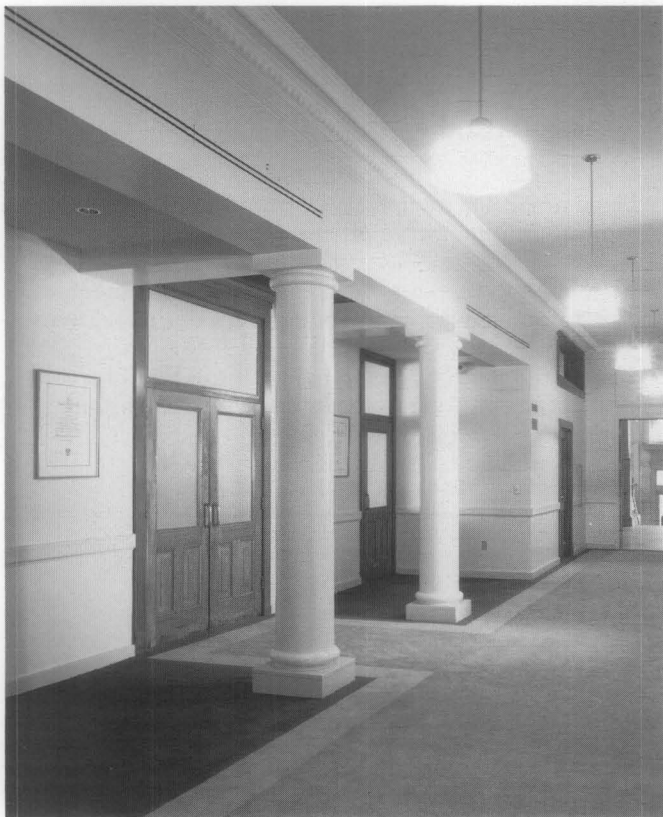
b. Central air conditioning was installed in the corridors of this circa 1900 school building by adding an air handler over the entrance from a vestibule. The custom-designed slot registers provide linear diffusers without detracting from the architecture of the space. Photo: Lautman Photography courtesy of Notter Finegold + Alexander Inc.

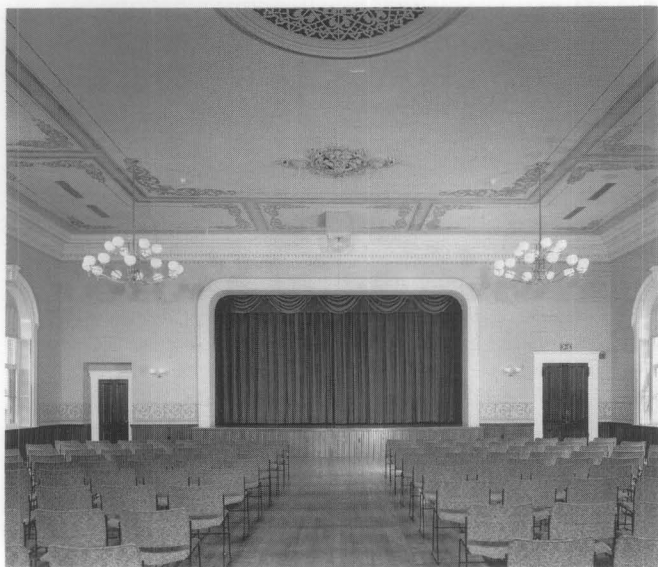
e. Town Hall, Andover, MA. The upstairs auditorium was restored and new mechanical systems were installed. Perimeter baseboard radiation provides heat and air handlers, located in the attic space provide air conditioning. The cast iron ceiling grille was adapted for return air and the supply registers were installed in a symmetrical and regular manner to minimize impact on the historic ceiling. Photo: David Hewitt/Anne Garrison for Ann Beha Associates.

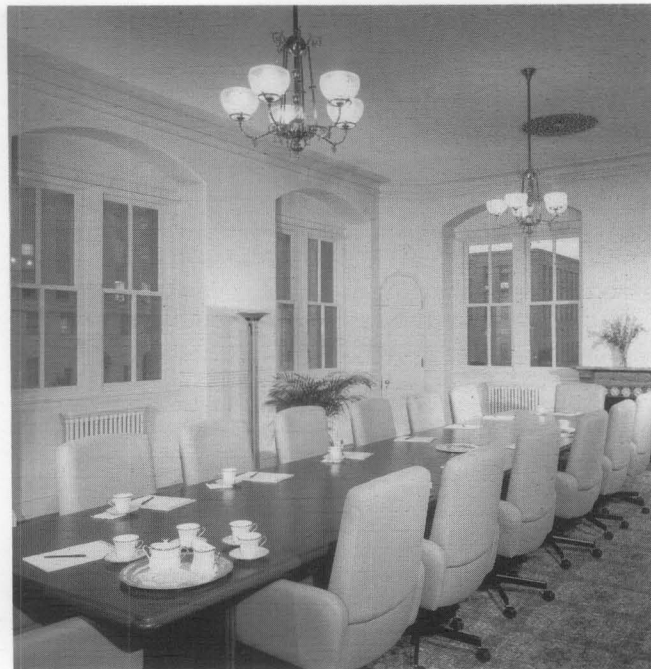
c. Conference room, Auditors Building, Washington, D.C. The historic steam radiators were retained for heating. The cast iron ceiling register was retained as a decorative element, but made inoperable to meet fire codes. Photo: Kenneth Wyner Photography courtesy of Notter Finegold + Alexander Inc.

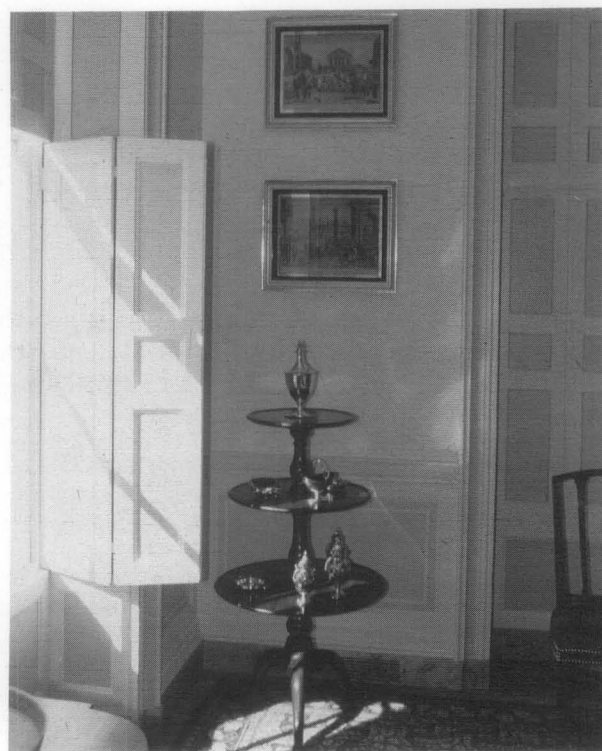
f. Homewood, Baltimore, MD. This elegant circa 1806 residence is now a house museum. The registers for the forced air ducted system seen behind the table legs, are grained to blend with the historic baseboards. The HVAC system uses a water/air system where chilled water and steam heat are converted to conditioned air. Photo: Courtesy Homewood Museum, Johns Hopkins University.

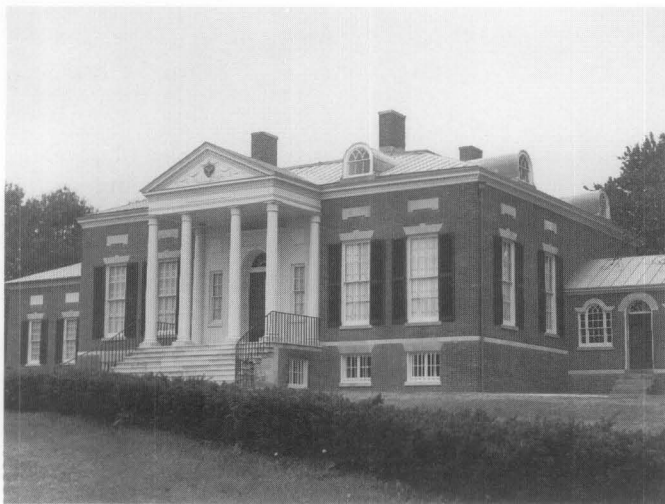
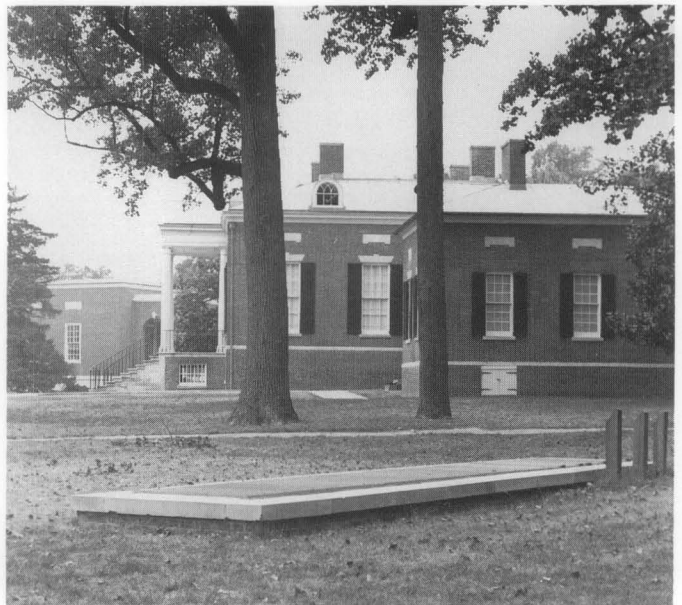
11. During the restoration of this 1806 National Historic Landmark (photo a), a new climate control system was installed. The architects removed all the earlier mechanical equipment from the house and installed new equipment in a 30' × 40' concrete vault located underground 150 feet from the house itself (photo b). Only conditioned air is blown into the house reusing much of the circa 1930s ductwork. Photos: Thomas C. Jester.
