# San Francisco Veterans Affairs Medical Center *Historic District Design Guidelines*

August 2015

U.S. Department of Veterans Affairs, Office of Construction and  
Facilities Management, Washington, D.C.

Contract No. VA101CFM-P-0096  
Task Order VACFM05-0018

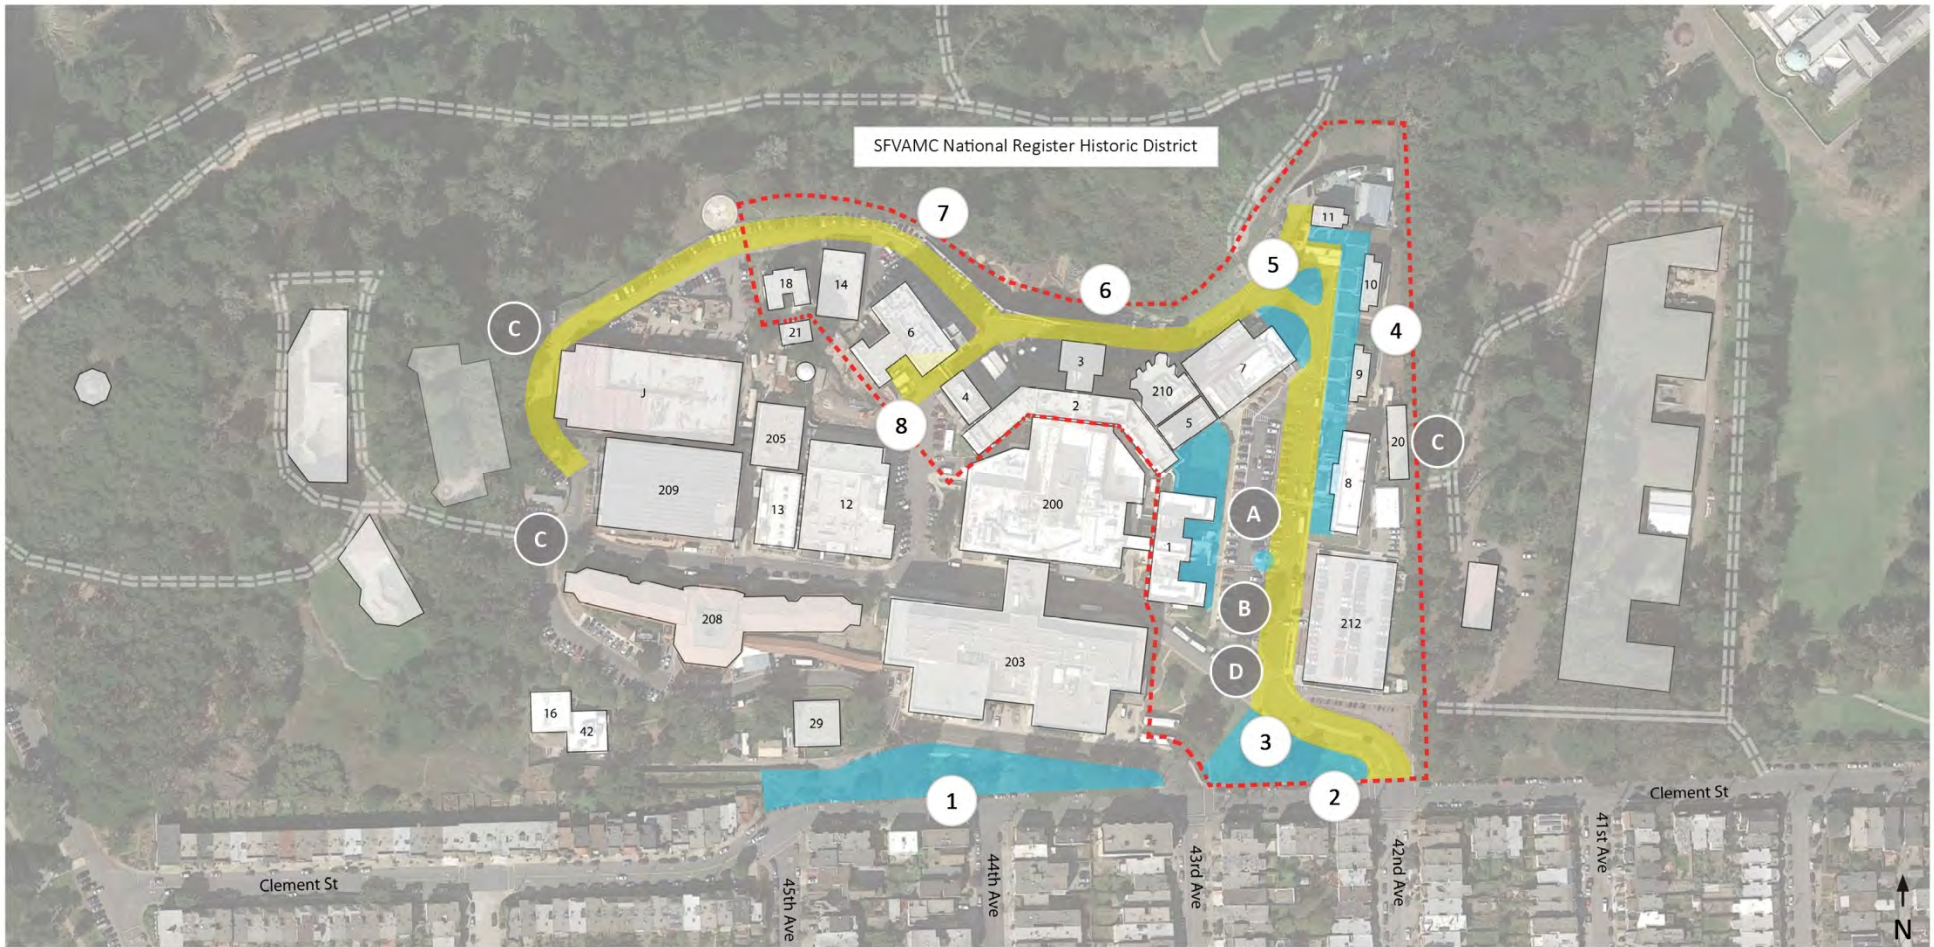
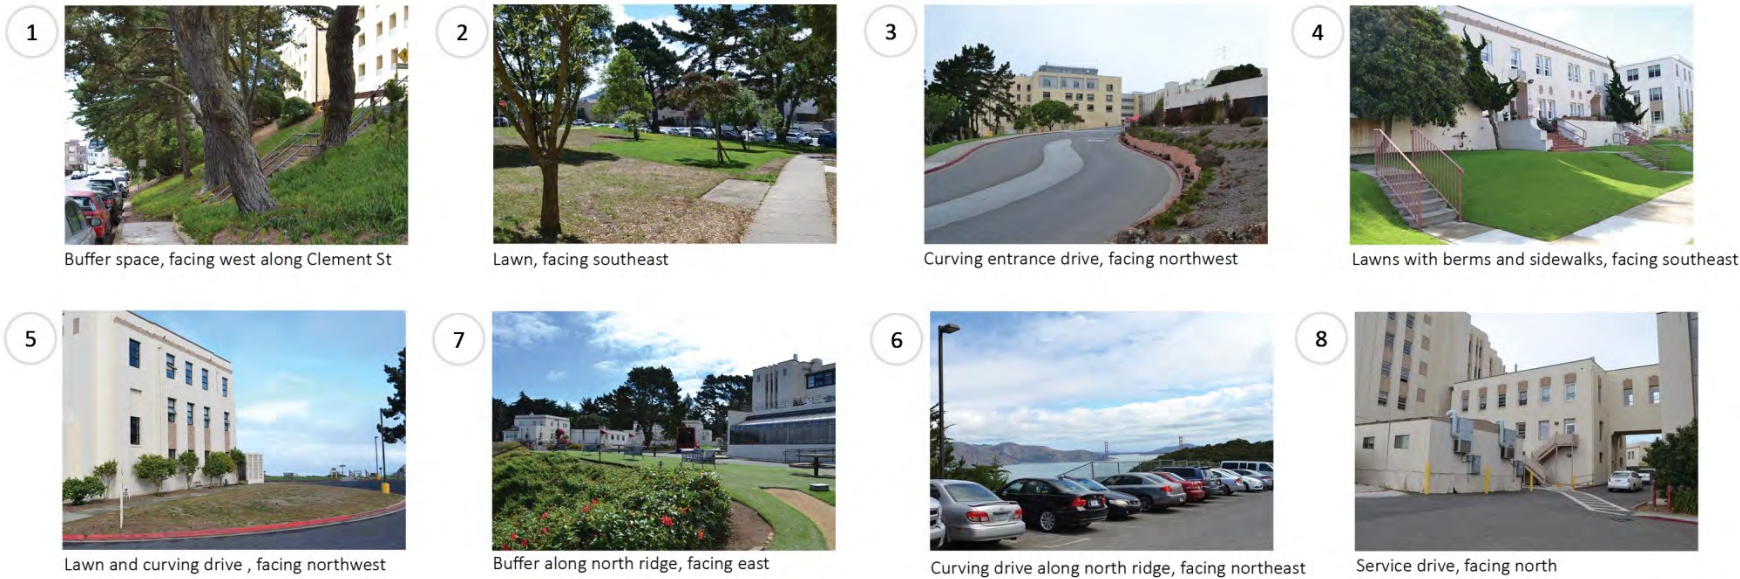
REMAINING HISTORIC LANDSCAPE FEATURES

Figure 8. Depiction of extant historic landscape features that are character-defining features of the historic campus.

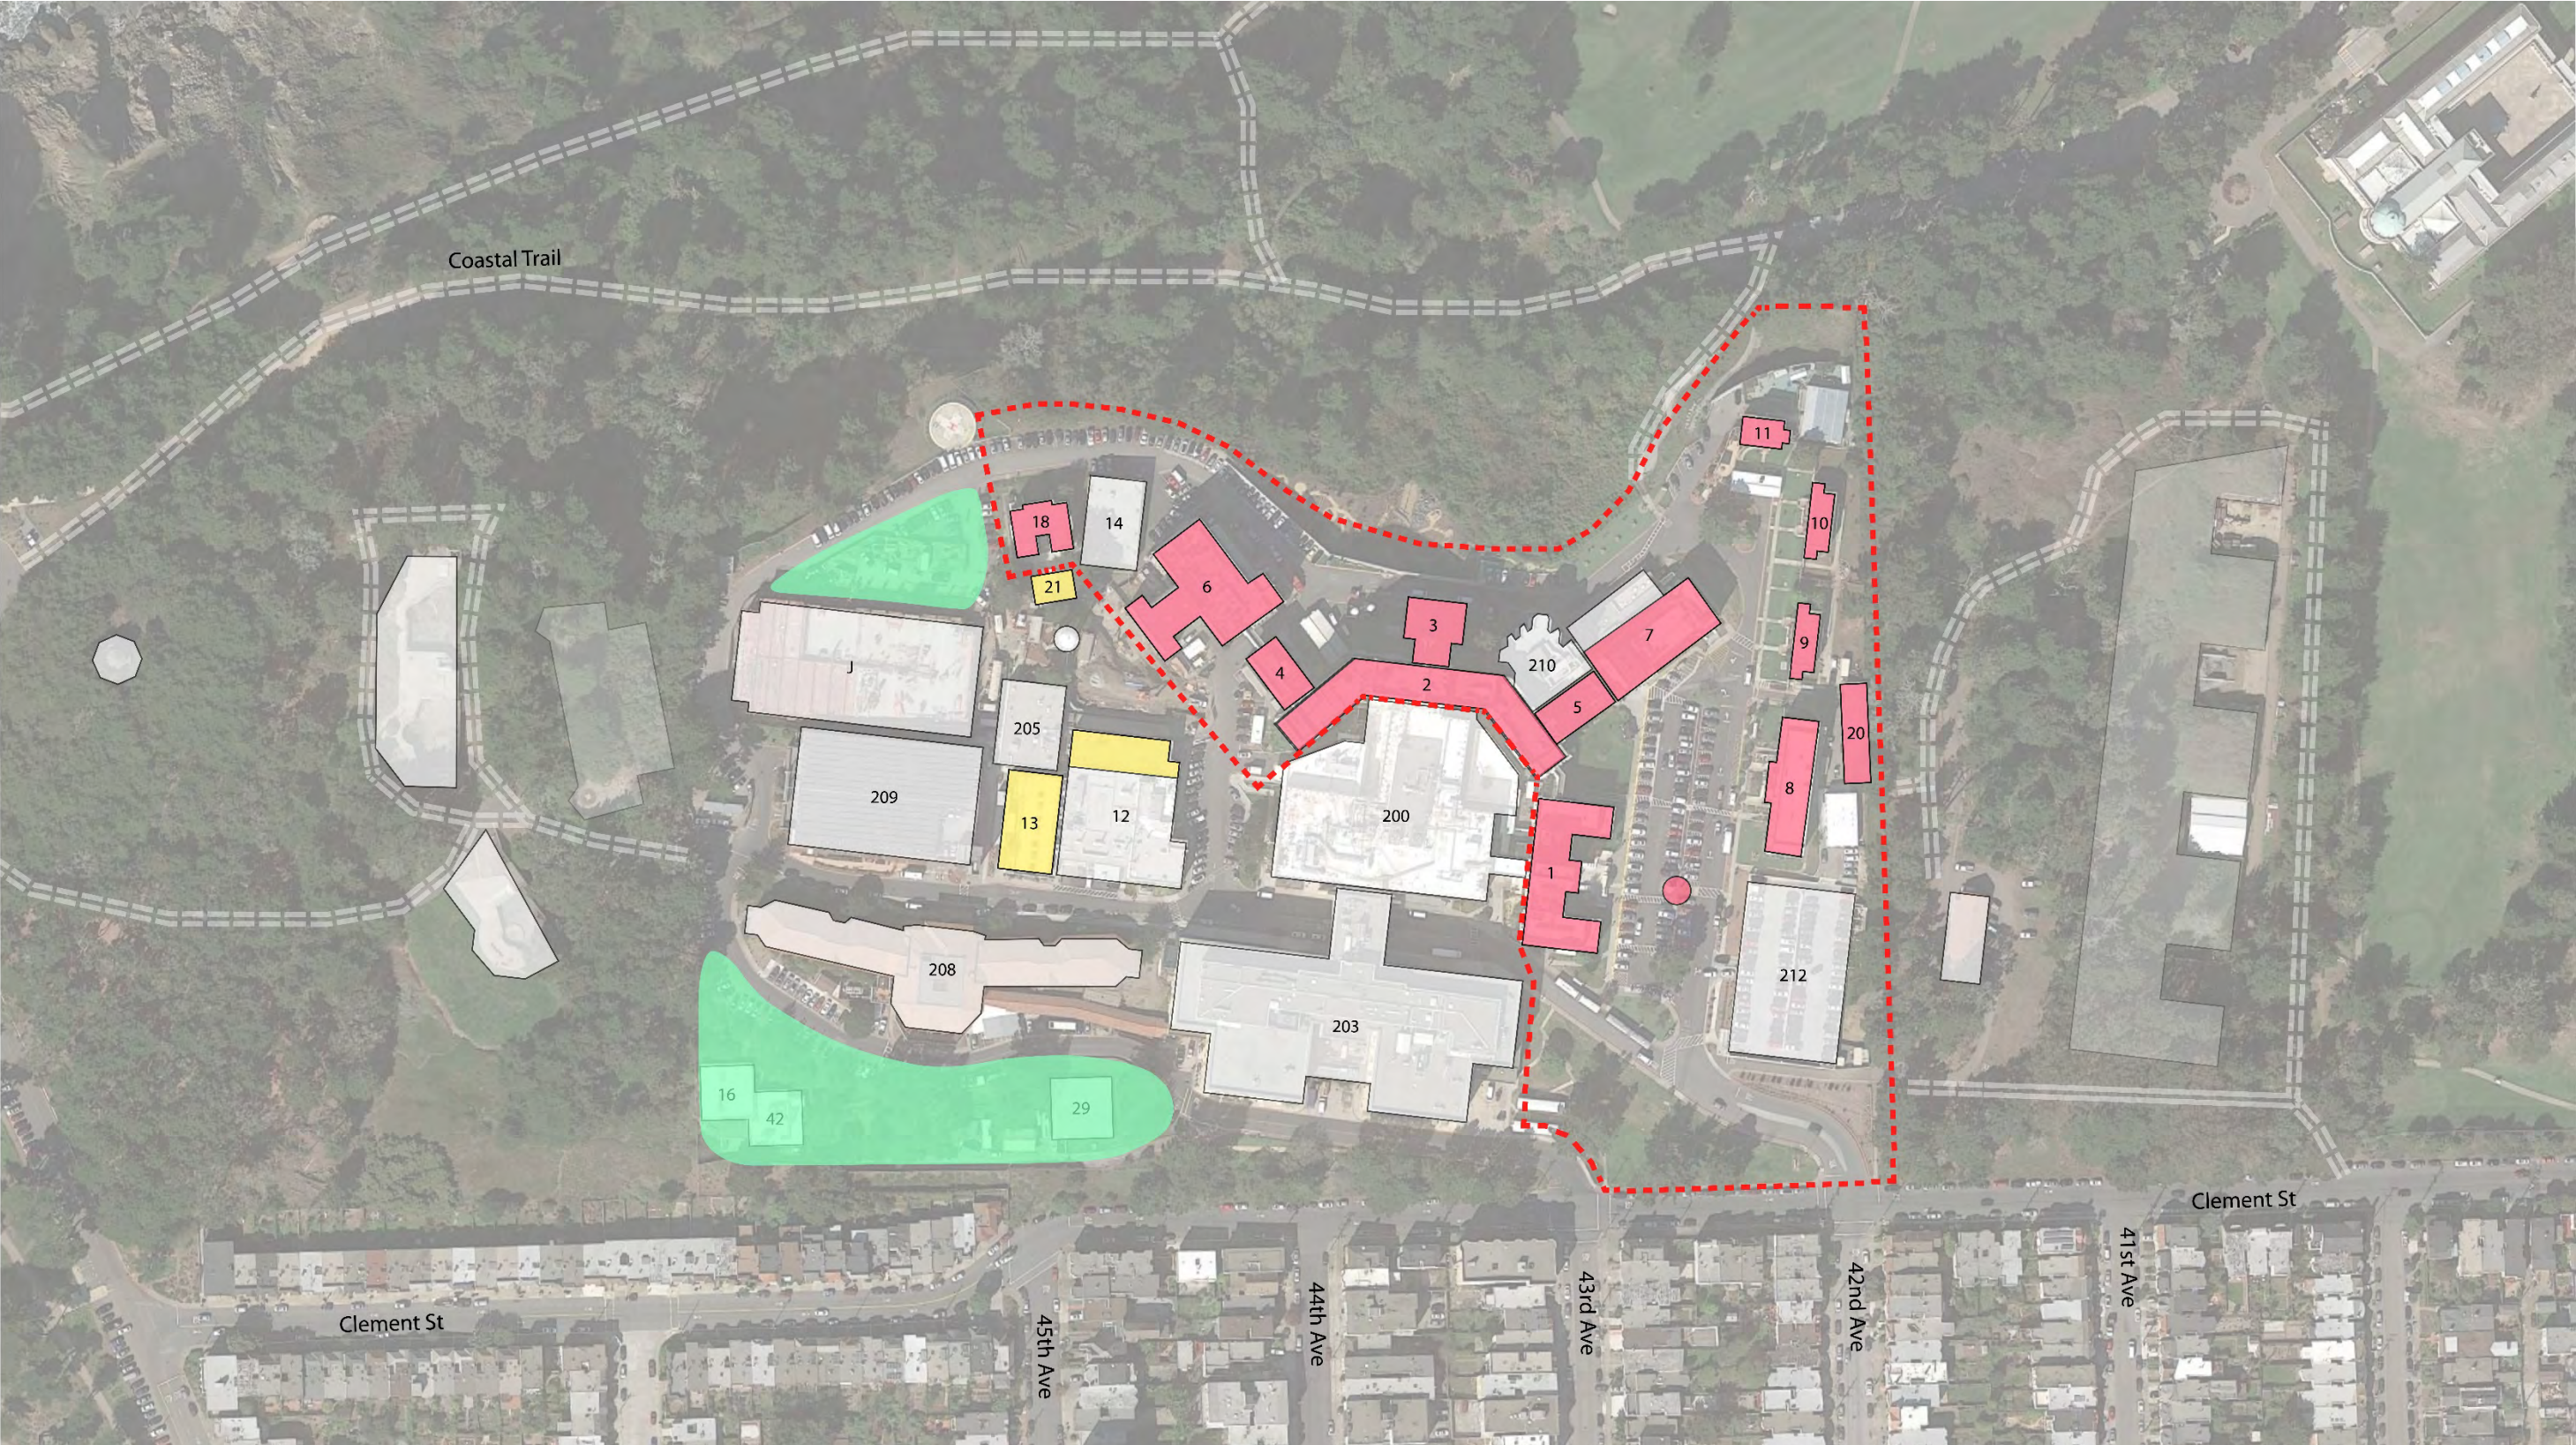
Figure 33. Site plan depicting the SFVAMC Historic District boundaries and contributing buildings in red, other historic 1934 buildings in yellow, and preferred areas for new construction in green.

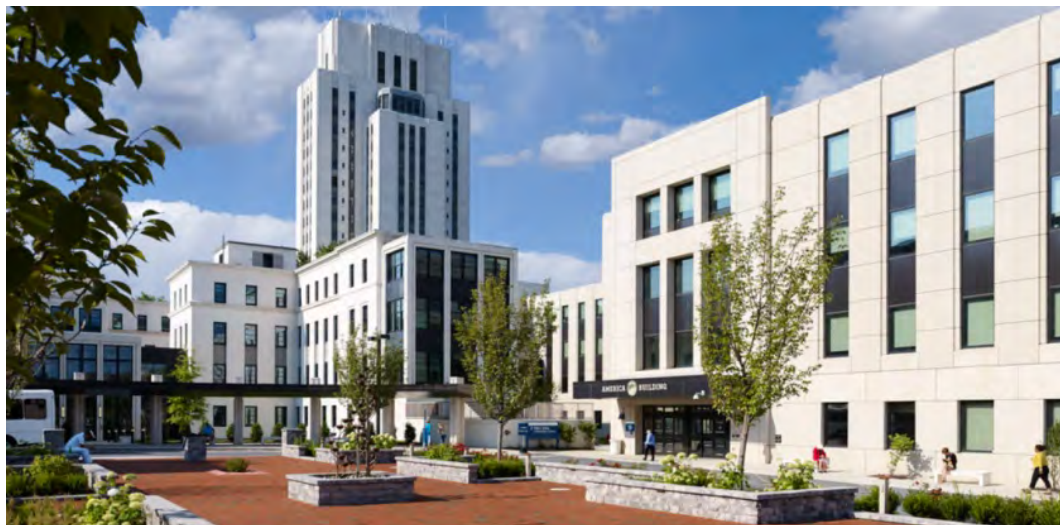
*Figure 36. Note how the color, massing, and verticality of the fenestration pattern of the new building on the right all reflect the design of the original historic buildings at the center and yet do not detract from them. National Naval Medical Center at the Walter Reed Military Medical Center in Bethesda, Maryland, designed by HOK, 2012, <http://www.hok.com/design/type/healthcare/walter-reed-national-military-medical-center/> (accessed August 24, 2014).*

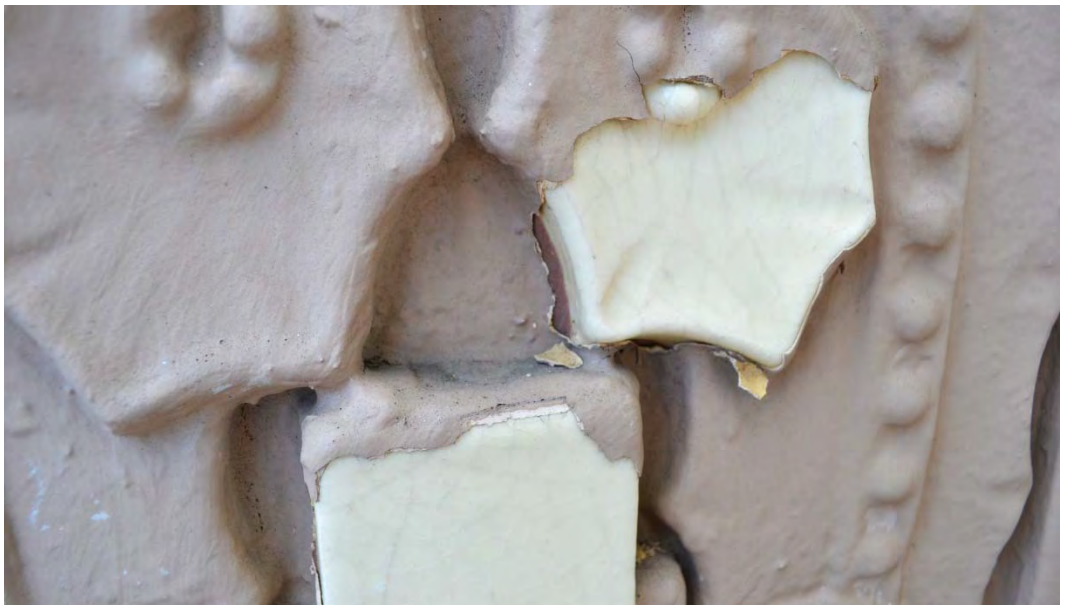
*Figure 39. Detail of original ornamental terra-cotta under peeling paint (photo by HHM, 2014).*

- If considering removing the non-historic paint that currently coats the historic terra cotta elements on the exterior walls, remove it using the gentlest means possible (see *Figures 39 and 40*). Moisture may become trapped between the paint and terra cotta, causing deterioration of the underlying materials. Test a small patch to ensure that the paint removal does not damage the underlying materials. Refer to NPS *Preservation Brief 7* included in *Appendix F* for additional guidance regarding historic terra cotta.

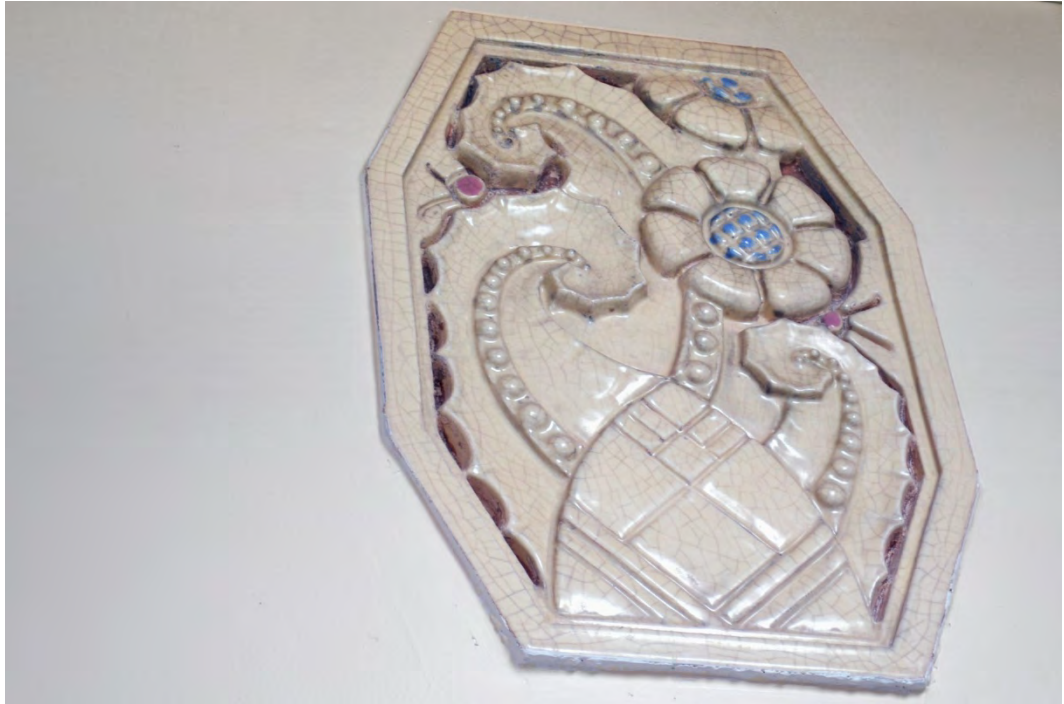
Figure 40. Detail of original unpainted ornamental terra-cotta panel located in Building 11, (photo by HHM, 2014).

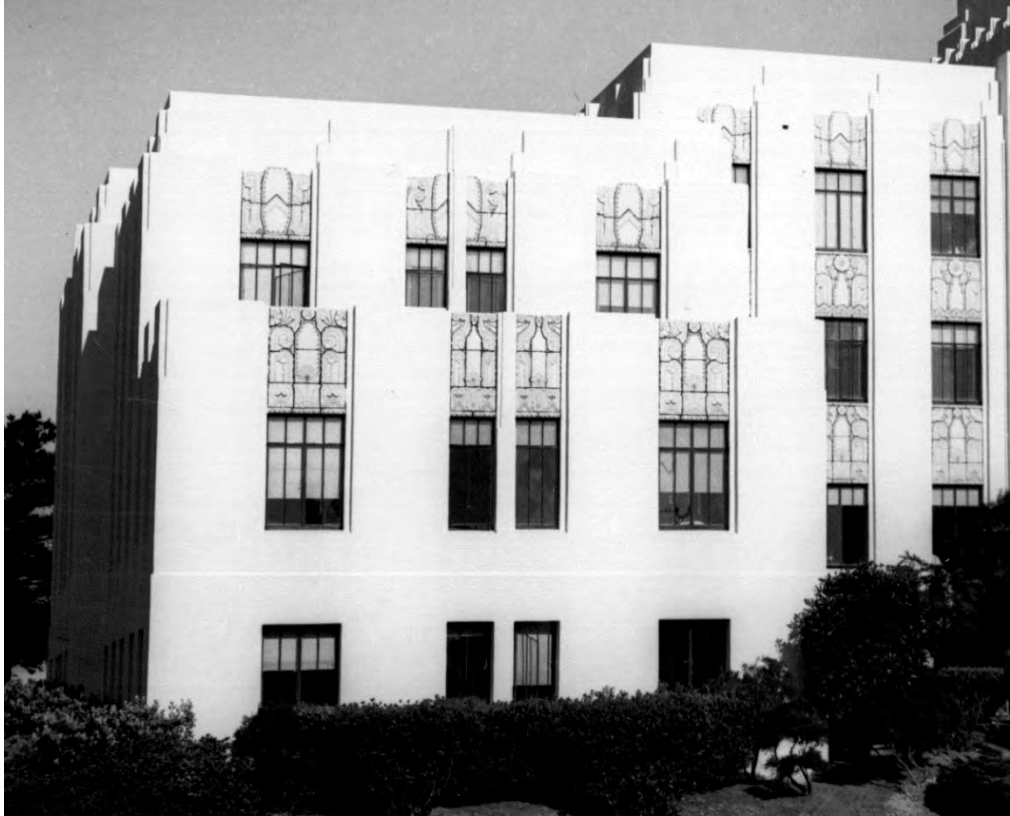
*Figure 41. South wing of Building 1 showing original steel frame casement windows, facing west, ca. 1950 (courtesy of SFVAMC).*

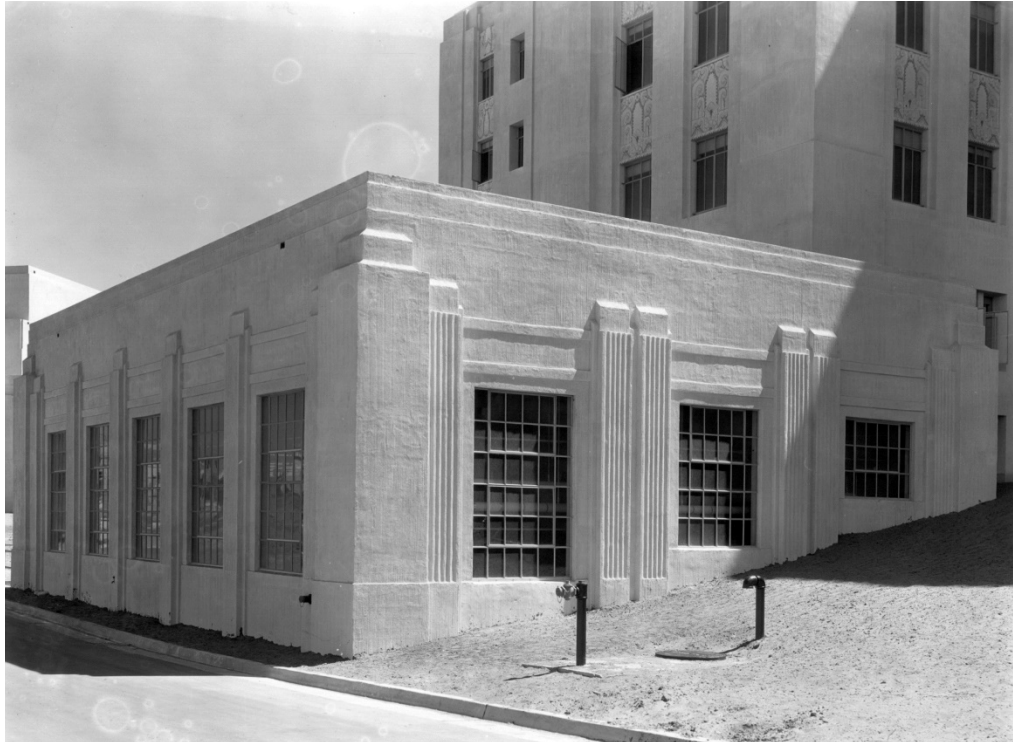
*Figure 42. Building 3 showing original steel frame windows, ca. 1934 (courtesy of SFVAMC).*

- The non-historic windows within the SFVAMC Historic District today generally are compatible with the design and style of the historic buildings and may be maintained in place. (See *Figures 42 through 45* for illustrations of extant windows.) However, non-historic windows should not be replaced with a new replica of the non-historic window; NPS guidance states “if replacement is chosen, the new windows must be based on existing fabric, on historic documentary or pictorial evidence or, they must be compatible with the historic character of the building.”<sup>13</sup> For the SFVAMC Historic District, historic photographs and architectural drawings documenting the appearance of the original windows are available. Additional information is provided in the NPS *Interpreting the Standards Bulletin 23: Selecting New Windows to Replace Non-Historic Windows*, included in *Appendix F*.

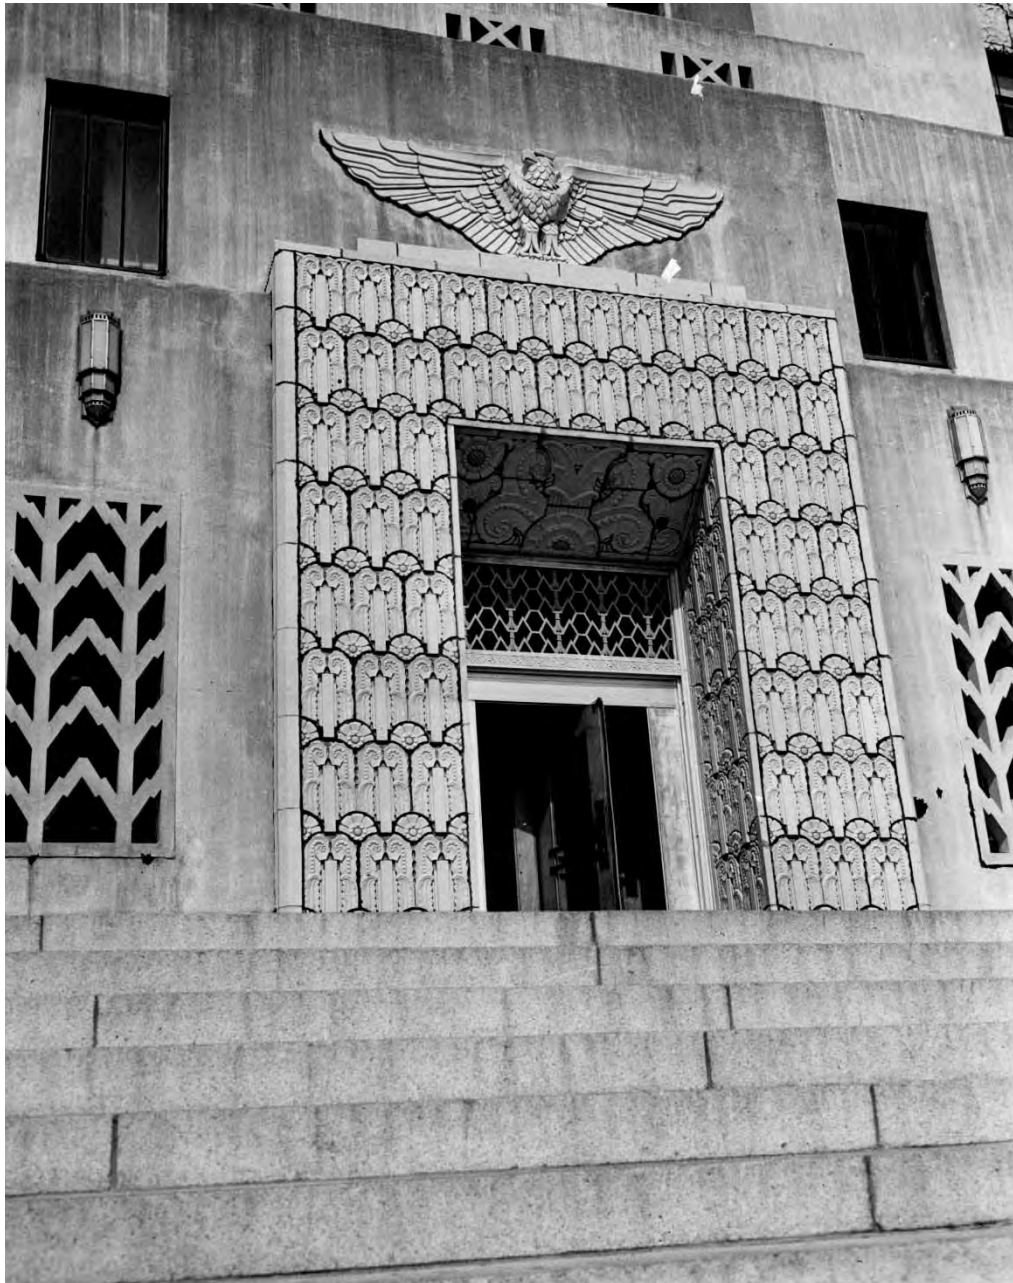
*Figure 48. Photograph of the original entrance of Building 2 in 1939, showing the steel revolving door and decorative steel grate at the transom (courtesy of SFVAMC).*

- Retain and repair historic doors, door surrounds, sidelights, and transoms (see *Figure 48*). Historic photographs taken during and immediately after construction suggest that double doors with inset octagonal panels were present on the campus historically.<sup>16</sup> Similar doors remain intact on Buildings 9, 10, 11, and 18, as illustrated in 2014 photographs in *Appendix G*, and are character-defining features of these buildings.<sup>17</sup> Preservation and repair methods should comply with the appropriate methods for steel or wood set forth in NPS Preservation Briefs Nos. 9 and 13, included in *Appendix F*.

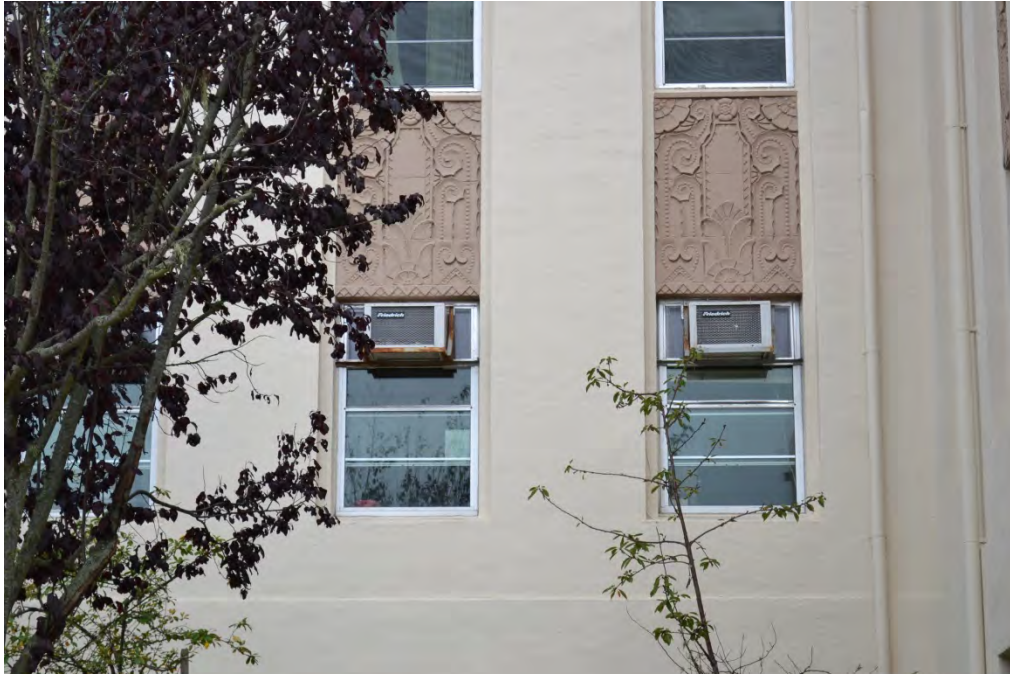
*Figure 50. Photo of non-historic window units installed in the non-historic windows at Building 1 (photo by HHM, 2014).*
