3 PRESERVATION BRIEFS

Improving Energy Efficiency in Historic Buildings

Jo Ellen Hensley and Antonio Aguilar

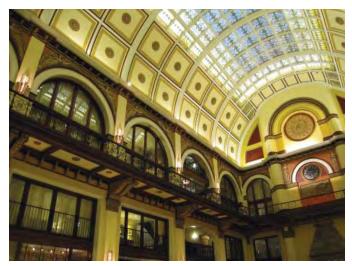
Fig. 1. A decorative, stained glass skylight allows natural daylight into the interior.

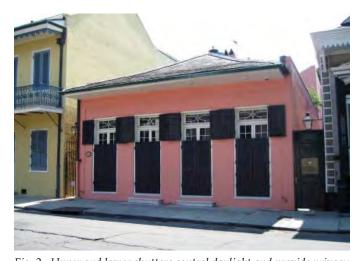
Fig. 2. Upper and lower shutters control daylight and provide privacy.

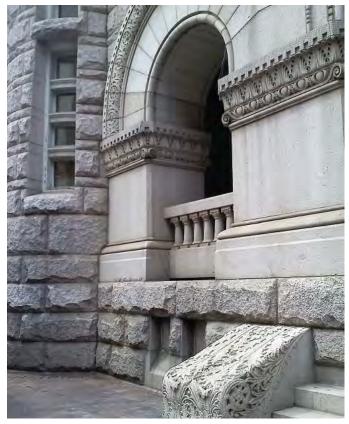
Fig. 3. Stone walls with substantial mass have high thermal inertia.

Thick masonry walls typical of the late-nineteenth and early-twentieth centuries have inherent thermal characteristics that keep the buildings cooler in the summer and warmer in the winter. Walls with substantial mass have the advantage of high thermal inertia, which reduces the rate of heat transfer through the wall. For instance, a wall with high thermal inertia, subjected to solar radiation for an hour, will absorb the heat at its outside surface, but slowly transfer it to the interior over a period as long as six hours. Conversely, a wall having the equivalent thermal resistance (R-value), but a substantially lower thermal inertia, will transfer the heat in perhaps as little as two hours. Heavy masonry walls also reduce the need for summer cooling. High thermal inertia is the reason many older public and commercial buildings without air conditioning still feel cool during the summer. The heat from the midday sun does not penetrate the buildings until late afternoon and evening, when it is less likely to be occupied or when exterior temperatures have fallen. Heavy masonry walls are also effective in moderating internal temperatures in the winter by dampening the overall peaks of heat gain and loss resulting in a flatter and more tolerable daily cycle. In areas that require cooling during the day and heating at night, masonry walls can help spread out excess heat gain from the day to cover some of the needed heating for the evening and night hours.

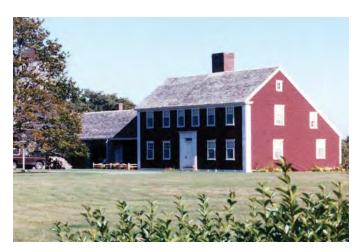
Fig. 4. A typical New England saltbox features a steeply sloping roof to shed snow and a floor plan organized around a central chimney to conserve heat.

influenced by the conditions of the local climate. Wide overhangs that sometimes extend to create porches minimize the heat gain from the sun in warmer climates, while steep, sloping roofs with minimal or no overhang prevail in colder climates to allow for shedding snow and increasing beneficial solar heat gain through the windows. Materials and color also influence the thermal performance of roofs. Metal and light colored roofs, for example, reflect sunlight and thereby reduce the heat gain from solar radiation.

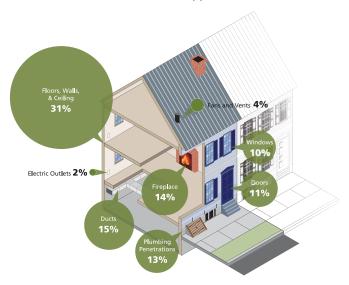
Fig. 8. Where Air Escapes From a House (by percentage) – Image based on data from Energy Savers, U.S. Department of Energy. Illustration: Blank Space LLC.

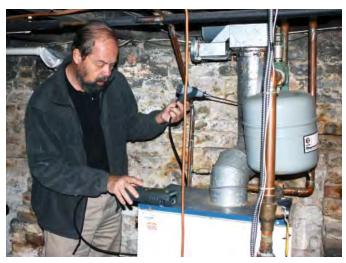
Fig. 9. An energy auditor tests the efficiency of a boiler.

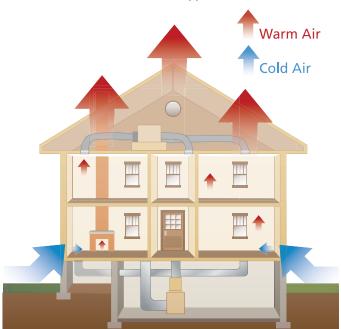
Fig. 10. The pattern of air movement referred to as the "stack effect". Illustration: Blank Space LLC.

Air flow into and out of buildings is driven by three primary forces: wind pressure, mechanical pressure and the stack effect. Cold outside air that infiltrates the building through big holes, as well as through loose windows, doors, and cracks in the outer shell of the building, causes the heating system to work harder and consume more energy. In a multi-story building, cold air that enters the building at lower levels, including the basement or crawlspace, will travel up through the building and exit out leaky windows, gaps around windows and the attic as a result of temperature and pressure differential. This pattern of air movement

is called the "stack effect." Not only is valuable conditioned air lost, but damaging moisture may also enter the wall cavities and attic spaces. To stop the stack effect, the top and bottom of the exterior walls, interfloor bypasses, and any existing chases or shafts must be sealed, or "draft proofed." The use of spray foam sealants in basement and attic cracks is a particularly useful technique for reducing air infiltration.

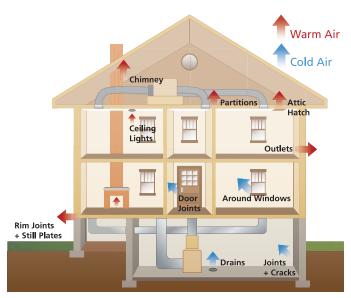
Fig. 11. Air infiltration and exfiltration. Illustration: Blank Space LLC.

Adding weatherstripping to doors and windows, sealing open cracks and joints at the base of walls and around windows and doors, sealing off recessed lighting fixtures from above, and sealing the intersection of walls and attic, will substantially reduce air leakage. When using exterior caulk to seal the intersection of siding and doors or windows, do not caulk the underside of clapboards or below windows to allow any liquid water to escape. When infiltration and, consequently, exfiltration are reduced, mechanical ventilation may be necessary to meet occupants' requirements for fresh air.

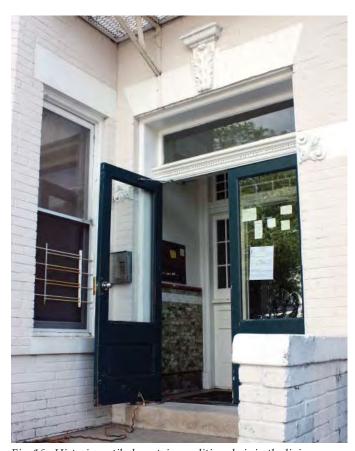
Fig. 16. Historic vestibules retain conditioned air in the living spaces.

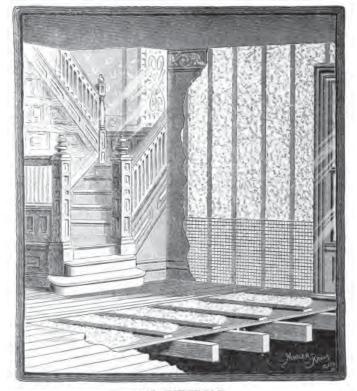
AN INTERIOR

Showing Mineral Wool in Floor, and Walls behind Wire Lath.

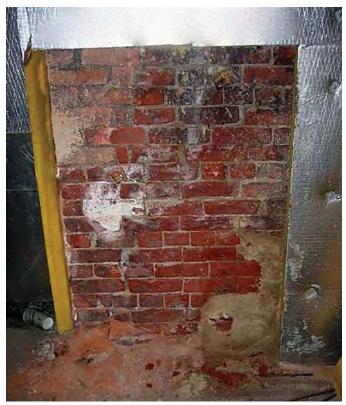
Fig. 21. The interior face of a brick masonry wall shows damage that resulted from the installation of a vapor retardant (foil facing) and thermal insulation. Photo: Simpson Gumpertz & Heger.

Depending on the type of masonry, exterior masonry walls can absorb a significant amount of water when it rains. Masonry walls dry both toward the exterior and the interior. When insulation is added to the interior side of a masonry wall, the insulation material reduces the drying rate of the wall toward the interior, causing the wall to stay wet for longer periods of time. Depending on the local climate, this could result in damage to the historic masonry, damage to interior finishes, and deterioration of wood or steel structural components

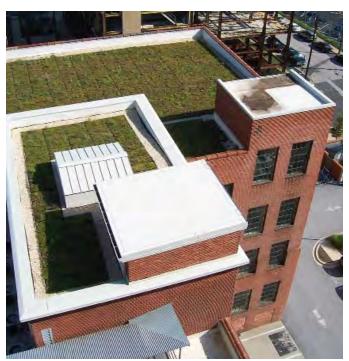
Fig. 22. Installation of both cool and green roofs in an urban environment.

light-colored or white roofs, and fiberglass shingles that have a coating of reflective crystals. All of these roofing materials reflect the sun's radiation away from the building, which lessens heat gain, resulting in a reduction of the cooling load. Cool roofs are generally not practical in northern climates where buildings benefit from the added heat gain of a dark-colored roof during colder months. Cool and green roofs are appropriate for use on historic buildings only when they are compatible with their architectural character, such as flat roofs with no visibility. A white-colored roof that is readily visible is not appropriate for historic metal roofs that were traditionally painted a dark color, such as green or iron oxide red. A white reflective roof is most suitable on flat roofed historic buildings. If a historic building has a slate roof, for example, removing the slate to install a metal roof is not a compatible treatment. It is never appropriate to remove a historic roof if the material is in good or repairable condition to install a cool roof. However, if the roof has previously been changed to an asphalt shingle roof, fiberglass shingles with special reflective granules may be an appropriate replacement.

A green roof consists of a thin layer of vegetation planted over a waterproofing system or in trays installed on top of an existing flat or slightly sloped roof. Green roofs are primarily beneficial in urban contexts to reduce the heat island effect in cities and to control storm water run-off. A green roof also reduces the cooling load of the building and helps cool the surrounding urban environment, filters air, collects and filters storm water, and can provide urban amenities, including vegetable gardens, for building occupants. The impact of increased

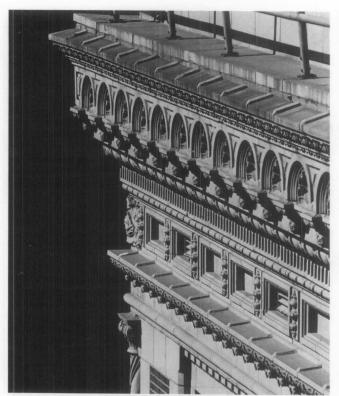
Figure 1. Terra-Cotta Detailing. Adaptable to every nuance of color, texture, and modeling, glazed architectural terra-cotta was ideally suited to satisfy the tastes of an eclectic age. Its popularity was, however, short lived; it endured only 30 or 40 years after its introduction as a building material late in the 19th century. (Larry Payne, Houston, Texas)

tectural terra-cotta. It provided for crisp, vigorous modeling of architectural details as the molds were cast directly from clay prototypes without loss of refinement. Glazed architectural terra-cotta could accommodate subtle nuances of modeling, texture and color. Compared to stone, it was easier to handle, quickly set and more affordable to use. Thought to be fireproof and waterproof, it was readily adaptable to structures of almost any height. The cost of molding the clay, glazing and firing the blocks, when compared to carving

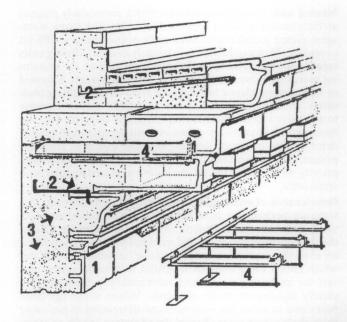
Figure 4. Typical Construction Detail of Glazed Architectural Terra-Cotta Ornament. Construction detailing was often complex. The terracotta units (1) which were laid in mortar were fitted with holes or slots to receive the metal anchors (2) (often called "Z" straps or "light iron") which were often fitted directly to the building frame. Masonry backfill (3)(either brick or poured cement) was laid between the terracotta units, with the building frame encasing the metal anchor. Overhanging or protruding elements were further secured by metal dowels or outriggers (4). (Detail, Architectural Terra Cotta, Charles E. White, Jr., 1920)

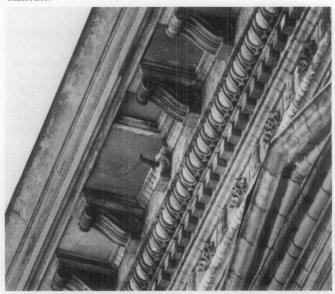
Figure 9. Deterioration of Metal Anchoring and Masonry Backfill. Trapped water may deteriorate masonry backfill or rust metal anchoring causing overhanging architectural elements to loosen and drop from the building. This is particularly true when unmaintained roof drainage systems fail and soak the masonry system. Note the exposed metal anchoring.

Deterioration of metal anchoring: Deteriorated anchoring systems are perhaps the most difficult form of glazed architectural terra-cotta deterioration to locate or diagnose. Often, the damage must be severe and irreparable before it is noticed on even the most intense "prima facie" examination. Water which enters the glazed architectural terra-cotta system can rust the anchoring system and substantially weaken or completely disintegrate those elements. Where water has been permitted to enter the system, some deterioration has more than likely taken place. Partial deterioration results in staining and material spalling. Total deterioration and the lack of any anchoring system may result in the loosening of the units themselves, threatening the architectural or structural integrity of the building. Recently, falling glazed architectural terra-cotta units have become a serious safety concern to many building owners and municipal governments (Fig. 9). Early detection of failing anchoring systems is exceedingly difficult.

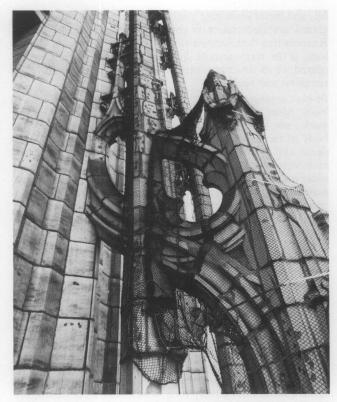
Figure 11. Temporary Stabilization Measures. Falling glazed architectural terra-cotta detailing has become a source of concern, particularly in dense urban areas and locations of high seismic activity. Nylon netting and metal strapping, while not seen as permanent preservation measures, do offer a temporary alternative to the removal of these elements.

Temporary stabilization: Stabilization measures are necessary when deterioration is so severe as to create a situation where pieces of glazed architectural terra-cotta may fall from the building. This is a particular concern with greatly exposed detailing: cornices, balconies, balustrades, urns, columns, buttresses, etc. Restoration work on these pieces is expensive and often must be carried on over a period of time. Unstable terra-cotta pieces are often removed or destroyed in lieu of such measures. This is particularly true in areas of heavy traffic-related vibrations or in earthquake zones. There are, however, less severe measures which may be employed on a temporary basis. Substantial success has been achieved in securing unstable glazed architectural terra-cotta pieces with metal strapping and nylon net (Fig. 11). While these measures should not be seen as permanent preservation solutions, they do offer temporary alternatives to the wanton destruction of significant glazed architectural terra-cotta detailing in the name of public safety and local code compliance.

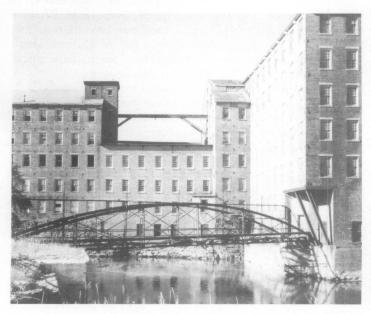
Figure 1. Windows are frequently important visual focal points, especially on simple facades such as this mill building. Replacement of the multipane windows here with larger panes could dramatically change the appearance of the building. The areas of missing windows convey the impression of such a change. Photo: John T. Lowe

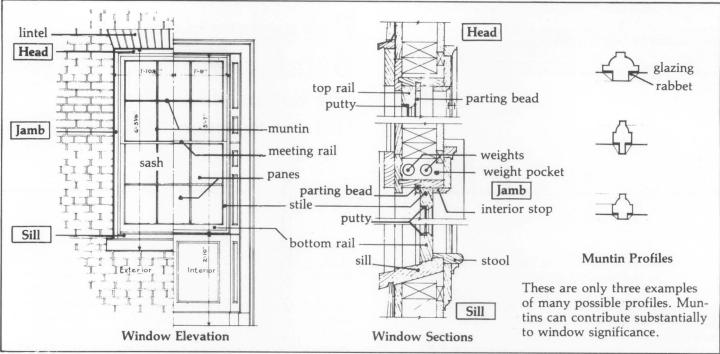
Figure 2. These drawings of window details identify major components, terminology, and installation details for a wooden double-hung window.

Historically, the first windows in early American houses were casement windows; that is, they were hinged at the side and opened outward. In the beginning of the eighteenth century single- and double-hung windows were introduced. Subsequently many styles of these vertical sliding sash windows have come to be associated with specific building periods or architectural styles, and this is an important consideration in determining the significance of windows, especially on a local or regional basis. Sitespecific, regionally oriented architectural comparisons should be made to determine the significance of windows in question. Although such comparisons may focus on specific window types and their details, the ultimate determination of significance should be made within the context of the whole building, wherein the windows are one architectural element (see figure 2).

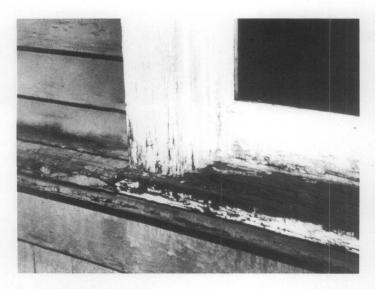
Figure 3. Deterioration of poorly maintained windows usually begins on horizontal surfaces and at joints where water can collect and saturate the wood. The problem areas are clearly indicated by paint failure due to moisture. Photo: Baird M. Smith. AIA

Each window should be examined for operational soundness beginning with the lower portions of the frame and sash. Exterior rainwater and interior condensation can flow downward along the window, entering and collecting at points where the flow is blocked. The sill, joints between the sill and jamb, corners of the bottom rails and muntin joints are typical points where water collects and deterioration begins (see figure 3). The operation of the window (continuous opening and closing over the years and seasonal temperature changes) weakens the joints, causing movement and slight separation. This process makes the joints more vulnerable to water which is readily absorbed into the end-grain of the wood. If severe deterioration exists in these areas, it will usually be apparent on visual inspection, but other less severely deteriorated areas of the wood may be tested by two traditional methods using a small ice pick.

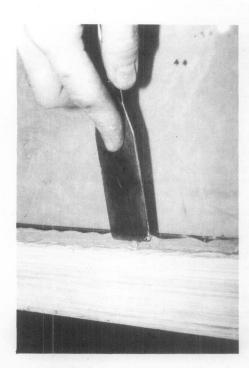
Figure 4d. Reglazing or replacement of the putty requires that the existing putty be removed manually, the glazing points be extracted, the glass removed, and the back putty scraped out. To reglaze, a bed of putty is laid around the perimeter of the rabbet, the pane is pressed into place, glazing points are inserted to hold the pane (shown), and a final seal of putty is beveled around the edge of the glass. Photo: John H. Myers

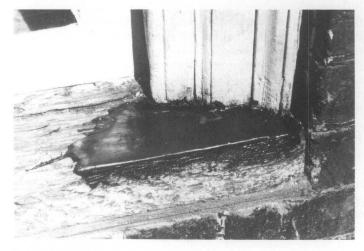
Figure 5. This illustrates a two-part epoxy patching compound used to fill the surface of a weathered sill and rebuild the missing edge. When the epoxy cures, it can be sanded smooth and painted to achieve a durable and waterproof repair. Photo: John H. Myers

Wood may also be strengthened and stabilized by consolidation, using semi-rigid epoxies which saturate the porous decayed wood and then harden. The surface of the consolidated wood can then be filled with a semi-rigid epoxy patching compound, sanded and painted (see figure 5). Epoxy patching compounds can be used to build up

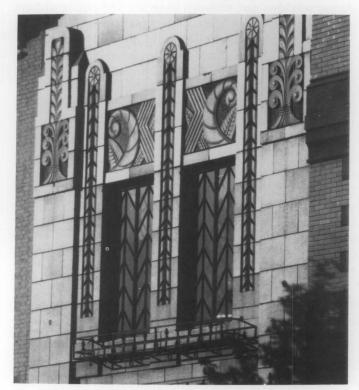
Fig. 1 Often highly distinctive in design and craftsmanship, rolled steel windows play an important role in defining the architectural character of many later nineteenth and early twentieth century buildings. Art Deco, Art Moderne, the International Style, and Post World War II Modernism depended on the slim profiles and streamlined appearance of metal windows for much of their impact. Photo: William G. Johnson.

Windows are among the most vulnerable features of historic buildings undergoing rehabilitation. This is especially the case with rolled steel windows, which are often mistakenly not deemed worthy of preservation in the conversion of old buildings to new uses. The ease with which they can be replaced and the mistaken assumption that they cannot be made energy efficient except at great expense are factors that typically lead to the decision to remove them. In many cases, however, repair and retrofit of the historic windows are more economical than wholesale replacement, and all too often, replacement units are unlike the originals in design and appearance. If the windows are important in establishing the historic character of the building (see fig. 1), insensitively designed replacement windows may diminish—or destroy—the building's historic character.

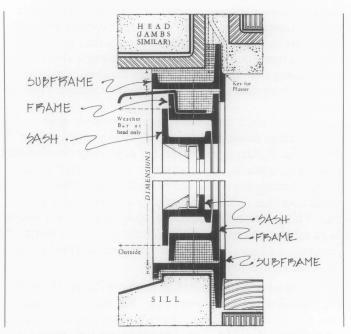
Fig. 3 A typical section through the top and bottom of a metal window shows the three component parts of the window assembly: subframe, frame, and sash. Drawings: Catalogue No. 15, January 1931; International Casement Co, Inc., presently Hope's Architectural Products, Inc., Jamestown, NY. Used with permission.

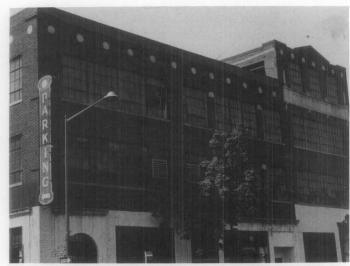
Fig. 5 Windows often provide a strong visual element to relatively simple or unadorned industrial or commercial buildings. This design element should be taken into consideration when evaluating the significance of the windows. Photo: Michael Auer.

Other elements in assessing the relative importance of the historic windows include the design of the windows and their relationship to the scale, proportion, detailing and architectural style of the building. While it may be easy to determine the aesthetic value of highly ornamented windows, or to recognize the importance of streamlined windows as an element of a style, less elaborate windows can also provide strong visual interest by their small panes or projecting planes when open, particularly in simple, unadorned industrial buildings (see fig. 5).

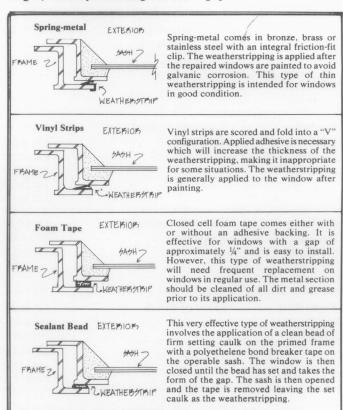
Fig. 8 APPROPRIATE TYPES OF WEATHERSTRIPPING FOR METAL WINDOWS. Weatherstripping is an important part of upgrading the thermal efficiency of historic steel windows. The chart above shows the jamb section of the window with the weatherstripping in place. Drawings: Sharon C. Park, AIA.

The first step in any weatherization program, caulking, has been discussed above under "Routine Maintenance." The second step is the installation of weatherstripping where the operable portion of the sash, often called the ventilator, and the fixed frame come together to reduce perimeter air infiltration (see fig. 8). Four types of weatherstripping appropriate for metal windows are spring-metal, vinyl strips, compressible foam tapes, and sealant beads. The spring-metal, with an integral friction fit mounting clip, is recommended for steel windows in good condition. The clip eliminates the need for an applied glue; the thinness of the material insures a tight closure. The weatherstripping is clipped to the inside channel of the rolled metal section of the fixed frame. To insure against galvanic corrosion between the weatherstripping (often bronze or brass), and the steel window, the window must be painted prior to the installation of the weatherstripping. This weatherstripping is usually applied to the entire perimeter of the window opening, but in some cases, such as casement windows, it may be best to avoid weatherstripping the hinge side. The natural wedging action of the weatherstripping on the three sides of the window often creates an adequate seal.

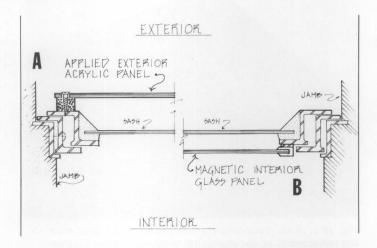
Fig. 9 Two examples of adding a second layer of glazing in order to improve the thermal performance of historic steel windows. Scheme A (showing jamb detail) is of a ¼" acrylic panel with a closed cell foam gasket attached with self-tapping stainless steel screws directly to the exterior of the outwardly opening sash. Scheme B (showing jamb detail) is of a glass panel in a magnetized frame affixed directly to the interior of the historic steel sash. The choice of using glass or acrylic mounted on the inside or outside will depend on the ability of the window to tolerate additional weight, the location and size of the window, the cost, and the long-term maintenance outlook. Drawing: Sharon C. Park, AIA.

The least expensive of these options is to install a clear material (usually rigid sheets of acrylic or glass) over the original window. The choice between acrylic and glass is generally based on cost, ability of the window to support the material, and long-term maintenance outlook. If the material is placed over the entire window and secured to the frame, the sash will be inoperable. If the continued use of the window is important (for ventilation or for fire exits), separate panels should be affixed to the sash without obstructing operability (see fig. 9). Glass or acrylic panels set in frames can be attached using magnetized gaskets, interlocking material strips, screws or adhesives. Acrylic panels can be screwed directly to the metal windows, but the holes in the acrylic panels should allow for the expansion and contraction of this material. A compressible gasket between the prime sash and the storm panel can be very effective in establishing a thermal cavity between glazing layers. To avoid condensation, 1/8" cuts in a top corner and diagonally opposite bottom corner of the gasket will provide a vapor bleed, through which moisture can evaporate. (Such cuts, however, reduce thermal performance slightly.) If condensation does occur, however, the panels should be easily removable in order to wipe away moisture before it causes corrosion.

The second method of adding a layer of glazing is to have independent storm windows fabricated. (Pivot and austral windows, however, which project on either side of the window frame when open, cannot easily be fitted with storm windows and remain operational.) The storm window should be compatible with the original sash configuration. For example, in paired casement windows, either specially fabricated storm casement windows or sliding units in which the vertical meeting rail of the slider reflects the configuration of the original window should be installed. The decision to place storm windows on the inside or outside of the window depends on whether the historic window opens in or out, and on the visual impact the addition of storm windows will have on the building. Exterior storm windows, however, can serve another purpose besides saving energy: they add a layer of protection against air pollutants and vandals, although they will partially obscure the prime window. For highly ornamental windows this protection can determine the choice of exterior rather then interior storm windows.

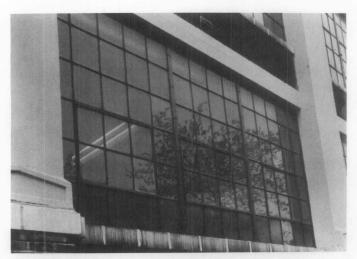
Fig. 10 b. Close-up view of the new replacement steel windows which matched the multi-lighted originals exactly. Photo: Charles Parrott.

historic windows, most of these manufacturers can reproduce the historic configuration if requested, and the cost is not excessive for large orders (see figs. 10a and 10b). Some manufacturers still carry the standard pre-World War II multi-light windows using the traditional 12" x 18" or 14" x 20" glass sizes in industrial, commercial, security, and residential configurations. In addition, many of the modern steel windows have integral weatherstripping, thermal break construction, durable vinyl coatings, insulating glass, and other desirable features.

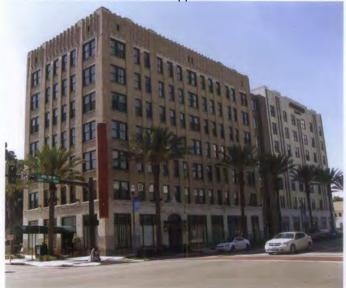
Figure 2. The new section on the right is appropriately scaled and reflects the design of the historic Art Deco-style hotel. The apparent separation created by the recessed connector also enables the addition to be viewed as an individual building.

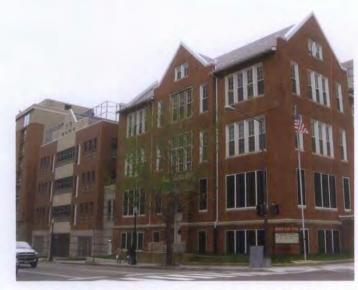
Figure 3. The red and buff-colored parking addition with a rooftop playground is compatible with the early-20th century school as well as with the neighborhood in which it also serves as infill in the urban setting.

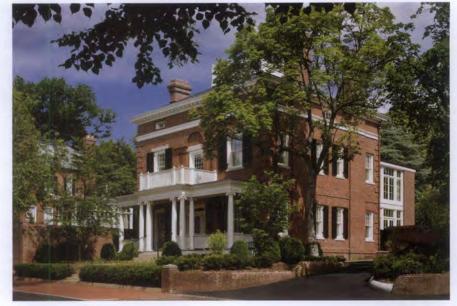
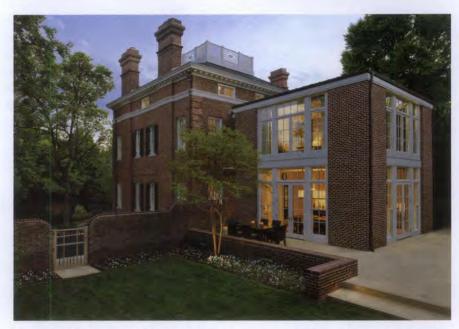
Figure 4. This glass and brick structure is a harmonious addition set back and connected to the rear of the Colonial Revival-style brick house. Cunningham/Quill Architects.

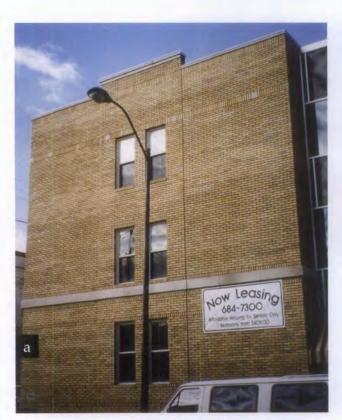
Figure 5. This addition (a) is constructed of matching brick and attached by a recessed connector (b) to the 1914 apartment building (c). The design is compatible and the addition is smaller and subordinate to the historic building (d).

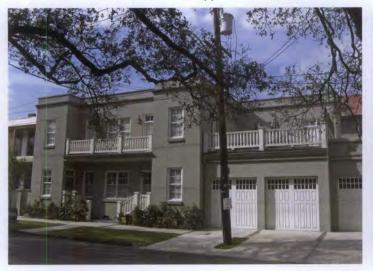
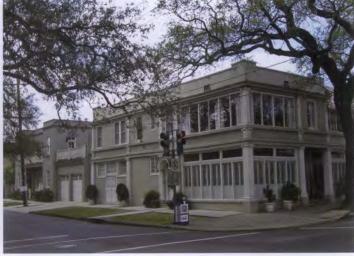
Figure 6. A new addition (left) is connected to the garage which separates it from the main block of the c. 1910 former florist shop (right). The addition is traditional in style, yet sufficiently restrained in design to distinguish it from the historic building.

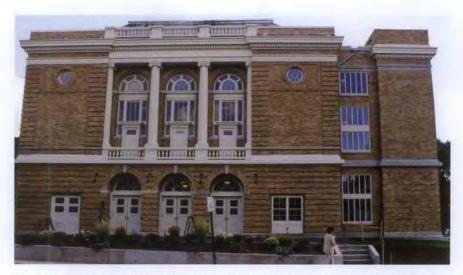
Figure 7. A vacant side lot was the only place a new stair tower could be built when this 1903 theater was rehabilitated as a performing arts center. Constructed with matching materials, the stair tower is set back with a recessed connector and, despite its prominent location, it is clearly subordinate and differentiated from the historic theater.

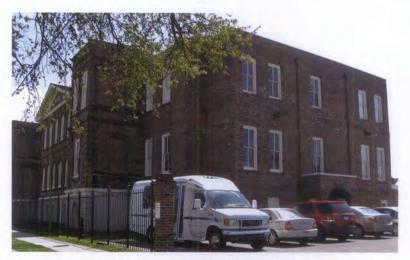
Figure 9. A simple, brick stair tower replaced two non-historic additions at the rear of this 1879 school building when it was rehabilitated as a women's and children's shelter. The addition is set back and it is not visible from the front of the school.

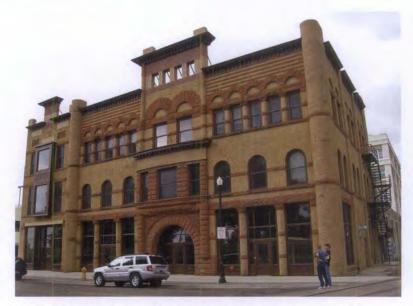
Figure 10. The small size and the use of matching materials ensures that the new addition on the left is compatible with the historic Romanesque Revival-style building.

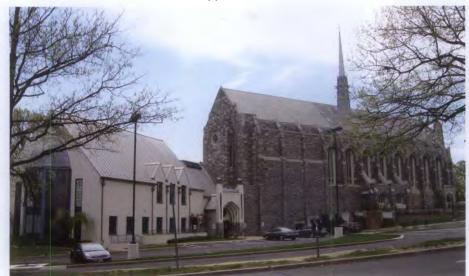
Figure 11. The addition to this early-20th century Gothic Revival-style church provides space for offices, a great hall for gatherings and an accessible entrance (left). The stucco finish, metal roof, narrow gables and the Gothic-arched entrance complement the architecture of the historic church. Placing the addition in back where the ground slopes away ensures that it is subordinate and minimizes its impact on the church (below).

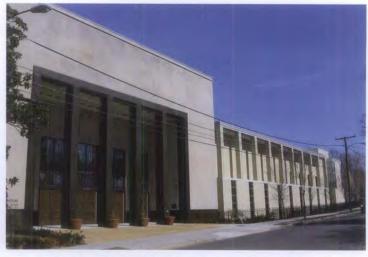
Figure 12. This 1954 synagogue (left) is accessed through a monumental entrance to the right. The new education wing (far right) added to it features the same vertical elements and color and, even though it is quite large, its smaller scale and height ensure that it is secondary to the historic resource.

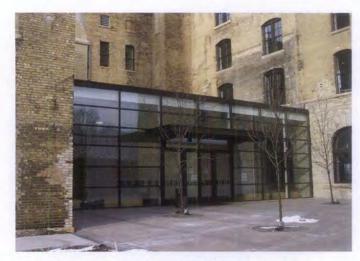
Figure 14. This glass addition was erected at the back of an 1895 former brewery during rehabilitation to provide another entrance. The addition is compatible with the plain character of this secondary elevation.

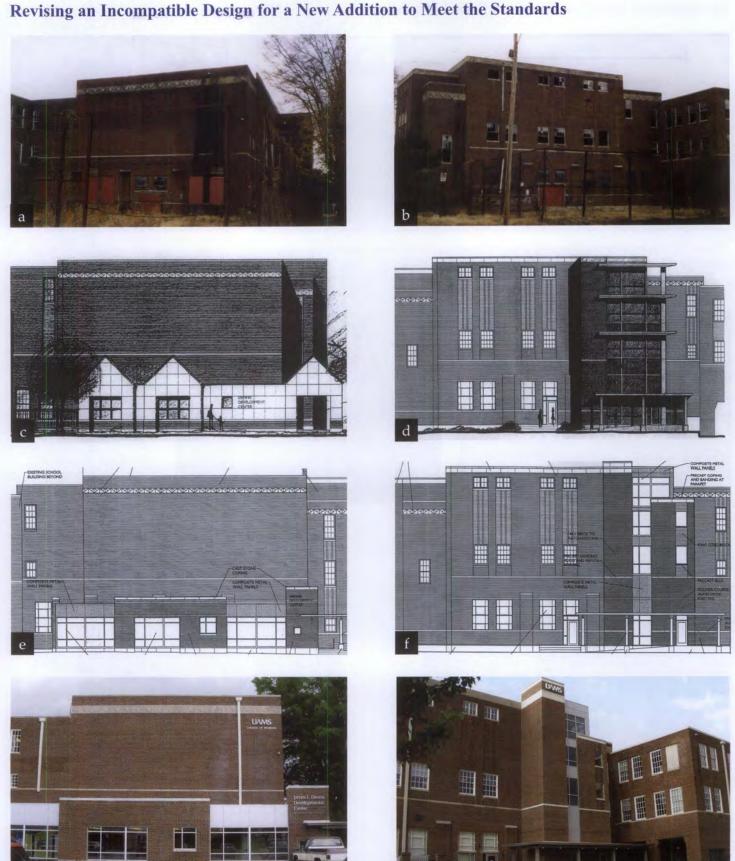
Figure 15. The rehabilitation of a c. 1930 high school auditorium for a clinic and offices proposed two additions: a one-story entrance and reception area on this elevation (a); and a four-story elevator and stair tower on another side (b). The gabled entrance (c) first proposed was not compatible with the flat-roofed auditorium and the design of the proposed stair tower (d) was also incompatible and overwhelmed the historic building. The designs were revised (e-f) resulting in new additions that meet the Standards (g-h).

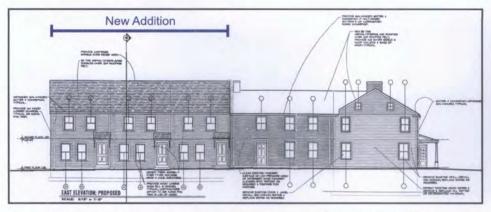
Figure 16. The proposal to add three row houses to the rear ell of this early-19th century residential property doubles its size and does not meet the Standards..

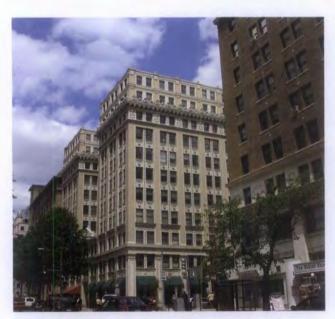
Figure 19. The upper two floors of this early-20th century office building were part of the original design, but were not built. During rehabilitation, the two stories were finally constructed. This treatment does not meet the Standards because the addition has given the building an appearance it never had historically.

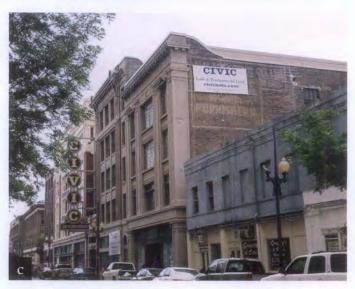
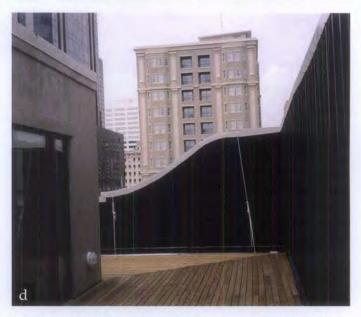
Figure 23. Colored flags marking the location of a proposed penthouse addition (a) were placed on the roof to help evaluate the impact and visibility of an addition planned for this historic furniture store (b). Based on this evaluation, the addition was constructed as proposed. It is minimally visible and compatible with the 1912 structure (c). The tall parapet wall conceals the addition from the street below (d).

A number of methods may be used to help evaluate the effect of a proposed rooftop addition on a historic building and district, including pedestrian sight lines, three-dimensional schematics and computer-generated design. However, drawings generally do not provide a true "picture" of the appearance and visibility of a proposed rooftop addition. For this reason, it is often necessary to construct a rough, temporary, full-size or skeletal mock up of a portion of the proposed addition, which can then be photographed and evaluated from critical vantage points on surrounding streets.

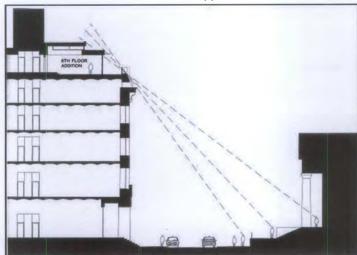
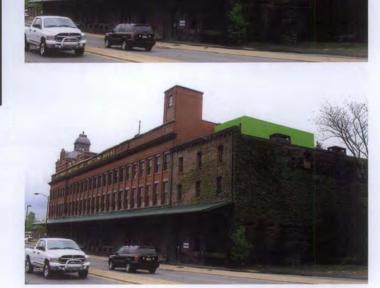
Figure 24. How to Evaluate a Proposed Rooftop Addition.

A sight-line study (above) only factors in views from directly across the street, which can be very restrictive and does not illustrate the full effect of an addition from other public rights of way. A mock up (above, right) or a mock up enhanced by a computer-generated rendering (below, right) is essential to evaluate the impact of a proposed rooftop addition on the historic building.

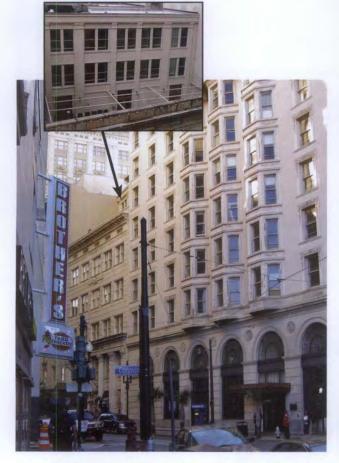
Figure 25. It was possible to add a compatible, three-story, penthouse addition to the roof of this five-story, historic bank building because the addition is set far back, it is surrounded by taller buildings and a deep parapet conceals almost all of the addition from below.

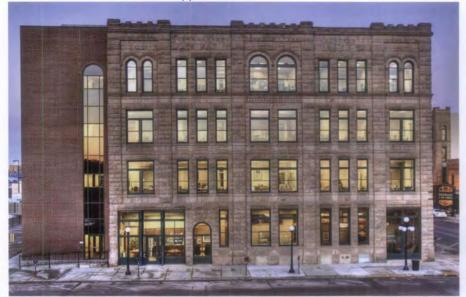
Figure 27. Although the new brick stair/elevator tower (left) is not visible from the front (right), it is on a prominent side elevation of this 1890 stone bank. The compatible addition is set back and does not compete with the historic building. Photos: Chadd Gossmann, Aurora Photography, LLC.

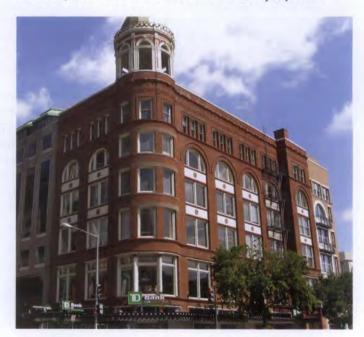
Figure 30. The small addition on the right of this late-19th century commercial structure is clearly secondary and compatible in size, materials and design with the historic building.

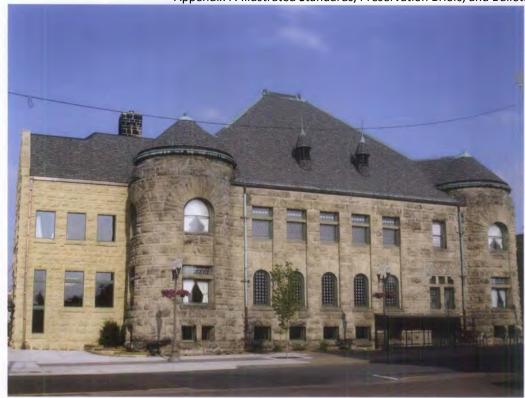
Figure 31. An elevator/stair tower was added at the back of this Richardsonian Romanesque-style theater when it was rehabilitated. Rough-cut stone and simple cut-out openings ensure that the addition is compatible and subordinate to the historic building. Photo: Chuck Liddy, AIA.

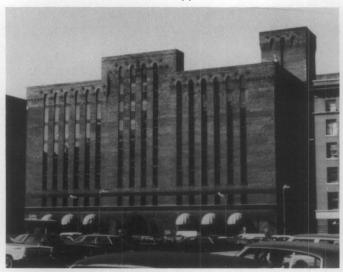
Overall Visual Character: Shape

The shape of a building can be an important aspect of its overall visual character. The building illustrated here, for example, has a distinctive horizontal box-like shape with the middle portion of the box projecting up an extra story. This building has other visual aspects that help define its overall character, including the pattern of vertical bands of windows, the decorative horizontal bands which separate the base of the building from the upper floors, the dark brown color of the brick, the large arched entranceway, and the castle-like tower behind the building.

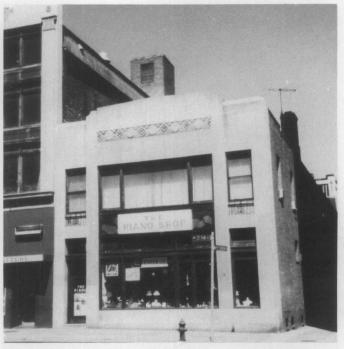
Overall Visual Character: Shape

It should not be assumed that only large or unusual buildings have a shape that is distinctive or identifiable. The front wall of this modest commercial building has a simple three-part shape that is the controlling aspect of its overall visual character. It consists of a large center bay with a two story opening that combines the storefront and the windows above. The upward projecting parapet and the decorative stonework also relate to and emphasize its shape. The flanking narrow bays enframe the side windows and the small iron balconies, and the main entrance doorway into the store. Any changes to the center portion of this three-part shape, could drastically affect the visual character of this building. Photo by Emogene A. Bevitt

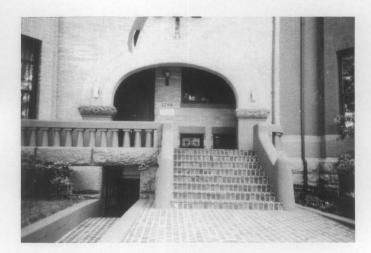
Overall Visual Character: Openings

The opening illustrated here dominates the visual character of this building because of its size, shape, location, materials, and craftsmanship. Because of its relation to the generous staircase, this opening places a strong emphasis on the principal entry to the building. Enclosing this arcade-like entry with glass, for example, would materially and visually change the character of the building. Photo by Lee H. Nelson.

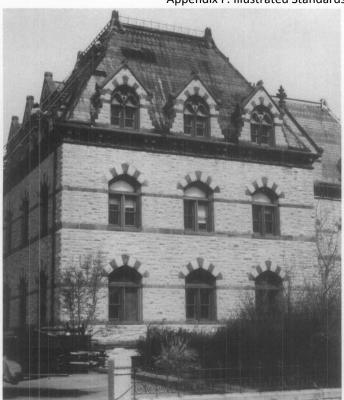
Overall Visual Character: Roof and Related Features

This building has a number of character-defining aspects which include the windows and the decorative stonework, but certainly the roof and its related features are visually important to its overall visual character. The roof is not only highly visible, it has elaborate stone dormers, and it also has decorative metalwork and slatework. The red and black slates of differing sizes and shapes are laid in patterns that extend around the roof of this large and freestanding building. Any changes to this patterned slatework, or to the other roofing details would damage the visual character of the building. Photo by Laurie R. Hammel

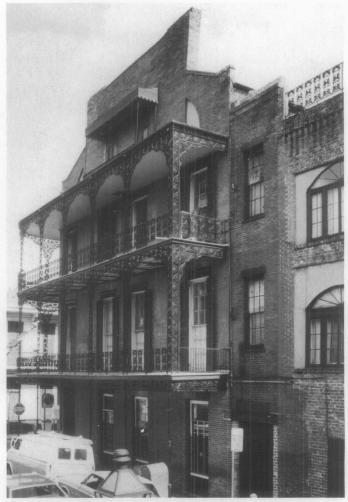
Overall Visual Character: Projections

A projecting porch or balcony can be very important to the overall visual character of almost any building and to the district in which it is located. Despite the size of this building (3 1/2 stories), and its distinctive roofline profile, and despite the importance of the very large window openings, the lacy wrap-around iron balcony is singularly important to the visual character of this building. It would seriously affect the character to remove the balcony, to enclose it, or to replace it with a balcony lacking the same degree of detail of the original material. Photo by Baird M. Smith

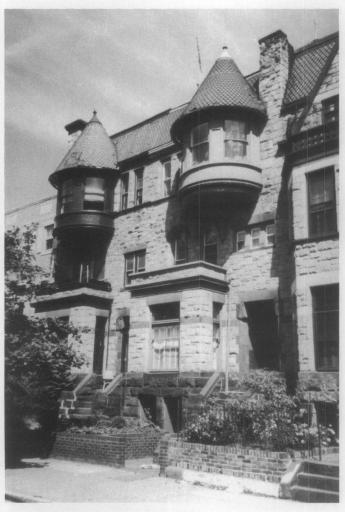
Overall Visual Character: Projections

Since these are row houses, any evaluation of their visual exterior character is necessarily limited to the front and rear walls; and while there are a number of things competing for attention in the front, it is the half round projecting bays with their conical roofs that contribute most prominently to the visual character. Their removal would be a devastating loss to the overall character, but even if preserved, the character could be easily damaged by changes to their color (as seen in the left bay which has been painted a dark color), or changes to their windows, or changes to their tile roofs. Though these houses have other fine features that contribute to the visual character and are worthy of preservation, these half-round bays demonstrate the importance of projecting features on an already rich and complex facade. Because of the repetitive nature of these projecting bays on adjacent row houses, along with the buildings' size, scale, openings, and materials, they also contribute to the overall visual character of the streetscape in the historic district. Any evaluation of the visual character of such a building should take into account the context of this building within the district. Photo by Lee H. Nelson

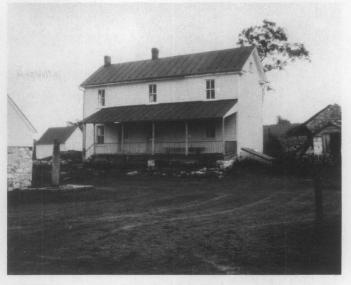
Overall Visual Character: Projections

Many buildings have projecting features such as porches, bay windows, or overhanging roofs, that help define their overall visual character. This projecting porch because of its size and shape, and because it copies the pitch and material of the main roof, is an important contributor to the visual character of this simple farmhouse. The removal or alteration of this porch would drastically alter the character of this building. If the porch were enclosed with wood or glass, or if gingerbread brackets were added to the porch columns, if the tin roof was replaced with asphalt, or if the porch railing was opened to admit a center stairway, the overall visual character could be seriously damaged. Although this projecting porch is an important feature, almost any other change to this house, such as changes to the window pattern, or changes to the main roof, or changes to the setting, would also change its visual character. Photo by Hugh C. Miller

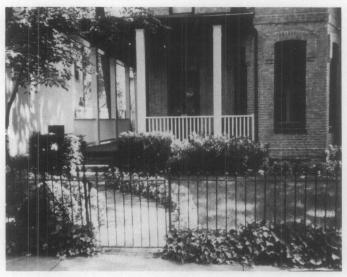
Overall Visual Character: Setting

Even architecturally modest buildings frequently will have a setting that contributes to their overall character. In this very urban district, set-backs are the exception, so that the small front yard is something of a luxury, and it is important to the overall character because of its design and materials, which include the iron fence along the sidewalk, the curved walk leading to the porch, and the various plantings. In a district where parking spaces are in great demand, such front yards are sometimes converted to off-street parking, but in this instance, that would essentially destroy its setting and would drastically change the visual character of this historic property. Photo by Lee H. Nelson

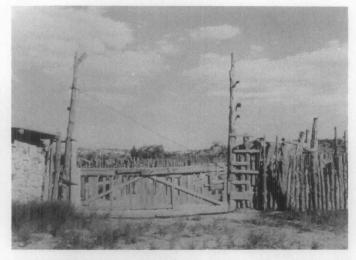
Overall Visual Character: Setting

Among the various visual aspects relating to the setting of an historic property are such site features as gardens, walks, fences, etc. This can include their design and materials. There is a dramatic difference in the visual character between these two fence constructions—one utilizing found materials with no particular regard to their uniformity of size or placement, and the other being a product of the machine age utilizing cast iron components assembled into a pattern of precision and regularity. If the corral fence were to be repaired or replaced with lumberyard materials its character would be dramatically compromised. The rhythm and regularity of the cast iron fence is so important to its visual character that its character could be altered by accidental damage or vandalism, if some of the fence top spikes were broken off thus interrupting the rhythm or pattern. Photos by Lee H. Nelson

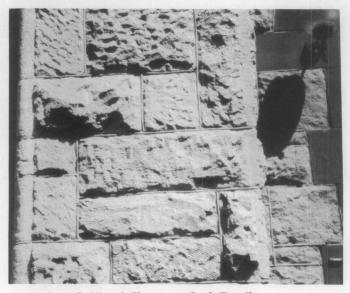
Arm's Length Visual Character: Craft Details

There are many instances where craft details dominate the arm's length visual character. As seen here, the craft details are especially noticeable because the stones are all of a uniform color, and they are all squared off, but their surfaces were worked with differing tools and techniques to create a great variety of textures, resulting in a tour-de-force of craft details. This texture is very important at close range. It was a deliberately contrived surface that is an important contributor to the visual character of this building. Photo by Lee H. Nelson

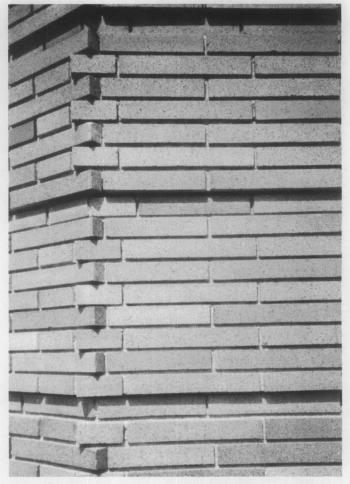
Arm's Length Visual Character: Craft Details

The arm's length visual character of this building is a combination of the materials and the craft details. Most of the exterior walls of this building consist of early 20th century Roman brick, precisely made, unusually long bricks, in varying shades of yellow-brown, with a noticeable surface spotting of dark iron pyrites. While this brick is an important contributor to the visual character, the related craft details are perhaps more important, and they consist of: unusually precise coursing of the bricks, almost as though they were laid up using a surveyor's level; a row of recessed bricks every ninth course, creating a shadow pattern on the wall; deeply recessed mortar joints, creating a secondary pattern of shadows; and a toothed effect where the bricks overlap each other at the corner of the building. The cumulative effect of this artisanry is important to the arm's length visual character, and it is evident that it would be difficult to match if it were damaged, and the effect could be easily damaged through insensitive treatments such as painting the brickwork or by careless repointing. Photo by Lee H. Nelson

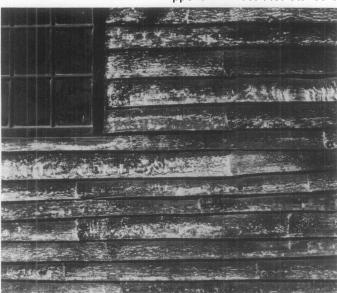
Arm's Length Visual Character: Craft Details

On some buildings, there are subtle aspects of visual character that cannot be perceived from a distance. This is especially true of certain craft details that can be seen only at close range. On this building, it is easily understood that the narrow, unpainted, and weathered clapboards are an important aspect of its overall visual character; but at close range there are a number of subtle but very important craft details that contribute to the handmade quality of this building, and which clearly differentiate it from a building with machine sawn clapboards. The clapboards seen here were split by hand and the bottom edges were not dressed, so that the boards vary in width and thickness, and thus they give a very uneven shadow pattern. Because they were split from oak that is unpainted, there are occasional wavy rays in the wood that stand against the grain. Also noticeable is the fact that the boards are of relatively short lengths, and that they have feather-edged ends that overlap each other, a detail that is very different from butted joints. The occasional large nail heads and the differential silvergray weathering add to the random quality of the clapboards. All of these qualities contribute to the arm's length visual character. Photo by Lee H. Nelson

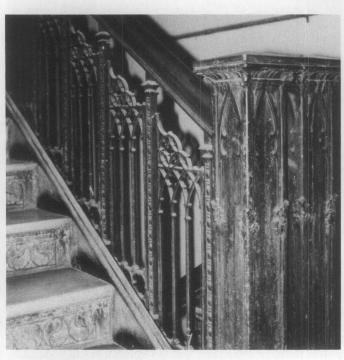
Interior Visual Character: Interior Features

Interior features are three-dimensional building elements or architectural details that are an integral part of the building as opposed to furniture. Interior features are often important in defining the character of an individual room or space. In some instances, an interior feature, like a large and ornamental open stairway may dominate the visual character of an entire building. In other instances, a modest iron stairway (like the one illustrated here) may be an important interior feature, and its preservation would be crucial to preserving the interior character of the building. Such features can also include the obvious things like fireplace mantles, plaster ceiling medallions, or panelling, but they also extend to features like hardware, lighting fixtures, bank tellers cages, decorative elevator doors, etc. Photo by David W. Look
