39 PRESERVATION BRIEFS

Holding the Line: Controlling Unwanted Moisture in Historic Buildings

Sharon C. Park, AIA

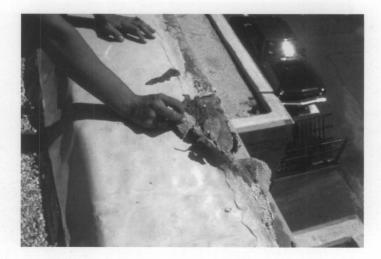
Fig. 1. Moisture problems, if not properly corrected, will increase damage to historic buildings. This waterproof coating trapped moisture from the leaking roof, causing portions of the masonry parapet to fail. Photo: NPS Files.

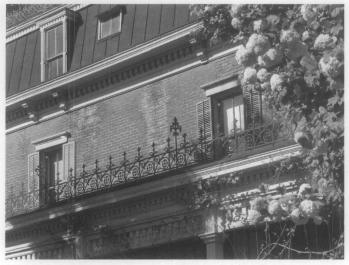
Fig. 4. Deferred maintenance often leads to blocked gutters and downspouts. This cracked gutter system allowed moisture to penetrate the upper exterior wall, erode mortar joints, and rot fascia boards. Photo: NPS files.

Above grade exterior moisture generally results from weather related moisture entering through deteriorating materials as a result of deferred maintenance, structural settlement cracks, or damage from high winds or storms (see fig. 4). Such sources as faulty roofs, cracks in walls, and open joints around window and door openings can be corrected through either repair or limited replacement. Due to their age, historic buildings are notoriously "drafty," allowing rain, wind, and damp air to enter through missing mortar joints; around cracks in windows, doors, and wood siding; and into uninsulated attics. In some cases, excessively absorbent materials, such as soft sandstone, become saturated from rain or gutter overflows, and can allow moisture to dampen interior surfaces. Vines or other vegetative materials allowed to grow directly on building

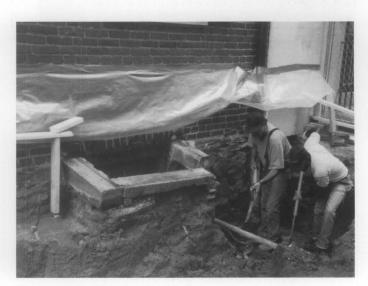
Fig. 5. Excavating this foundation revealed that the downspout pipe had corroded at the "u-trap" and was leaking moisture into the soil. Openings around the horizontal water supply line and cracks in the wall allowed moisture to penetrate the basement in multiple locations. Photo: author.

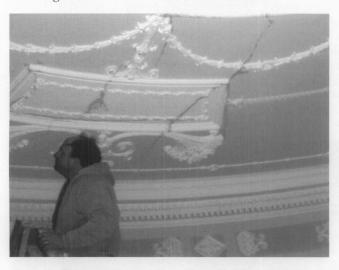
Fig. 6. Uninsulated plumbing pipes close to the exterior wall froze and cracked, wetting this ornamental plaster ceiling before the water supply line could be shut off. As a result, limited portions of the ceiling needed reattaching. Photo: author.

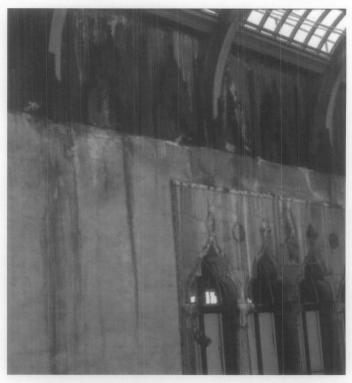
Fig. 7. Condensation dripping from the large overhead courtyard skylight was damaging the masonry in this museum. A new skylight with thermal glazing was installed, replacing the deteriorated singleglazed unit. A new climate control system monitors interior temperature and humidity. Photo: © Isabella Stewart Gardner Museum, Boston.

Humidified climate control systems are generally a major problem in museums housed within historic buildings. They produce between 35%-55% RH on average which, as a vapor, will seek to dissipate and equalize with adjacent spaces (see fig. 7). Moisture can form on single-glazed windows in winter with exterior temperatures below 30 F and interior temperatures at 70 F with as little as 35% RH. Frequent condensation on interior window surfaces is an indication that moisture is migrating into exterior walls, which can cause long-term damage to historic materials. Materials and wall systems around climate controlled areas may need to be made of moisture resistant finishes in order to handle the additional moisture in the air. Moist interior conditions in hot and humid climates will generate mold and fungal growth. Unvented mechanical equipment, such as gas stoves, driers, and kerosene heaters, generate large quantities of moisture. It is important to provide adequate ventilation and find a balance between interior temperature, relative humidity, and airflow to avoid interior moisture that can damage historic buildings.

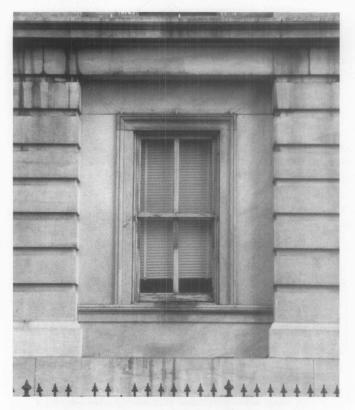
Fig. 10. Infiltration of damp air can occur around loose-fitting or deteriorated window sash and through cracks or open joints in building exteriors. Photo: Ann Brooks Prueher.

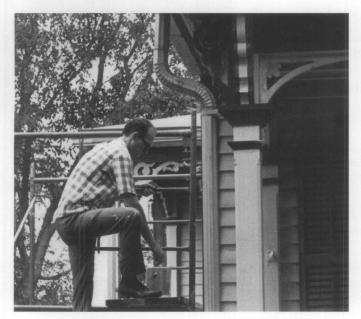
Fig. 19. Maintaining gutters and downspouts in good operable condition, repairing exteriors to keep water out, redirecting damaging moisture away from foundations and controlling interior moisture and condensation are all important when holding the line on moisture deterioration. Photo: Nebraska State Historical Society.

Once the building has been repaired and the larger moisture issues addressed, it is important to keep a record of additional evidence of moisture problems and to protect the historic or old building through proper cyclical maintenance (see fig. 19) In some cases, particularly in museum environments, it is critical to monitor areas vulnerable to moisture damage. In a number of historic buildings, inwall moisture monitors are used to ensure that the moisture purposely generated to keep relative humidity at ranges appropriate to a museum collection does not migrate into walls and cause deterioration. The potential problem with all systems is the failure of controls, valves, and panels over time. Back-up systems, warning devices, properly trained staff and an emergency plan will help control damage if there is a system failure.

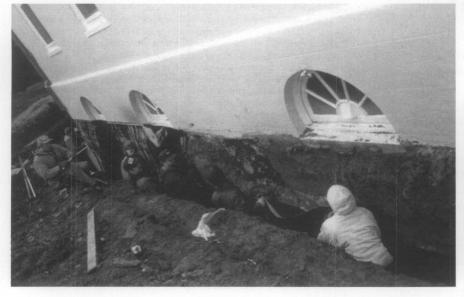
I. Critically damp foundation walls were protected with a layer of bentonite clay to reduce moisture penetration. This work was in combination with new downspouts that were connected to drainage boots that deposited captures roof run-off away from the foundation. Photo: Courtesy, Larry D. Dermody and the National Trust for Historic Preservation.

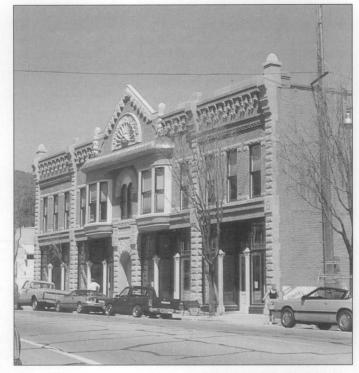
22. When undertaking a substantial rehabilitation to include seismic reinforcement, it is also an opportune time to restore lost or damaged features. The owner of this commercial building, using the Historic Rehabilitation Tax Credits, restored the original bay and parapet gable, and stone detailing that had been removed in an earlier insensitive remodeling. Photo: David Look.

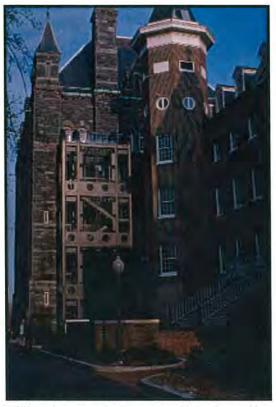
This modern, metal stair tower addition located between an existing projecting tower and articulated corner is compatible with the character of the historic structure. It is also located on the rear elevation of the building, and is not visible from major public vantage points.

Application 2 (Compatible addition): A second example involves a large university building, including a late-19th century stone Gothic Style historic structure with a later brick historic addition abuting it. A new stair to provide an additional means of egress was added to the rear elevation of the original structure, inconspicuously placed near the intersection with the later addition. The new stair is constructed in modern materials and is clearly differentiated from the old. Moreover, its simple, contemporary design is compatible with the historic building. Finally, the addition is not visible when looking at the building's primary elevation. Accordingly, this stair tower addition successfully conforms with the Secretary of the Interior's Standards for Rehabilitation.

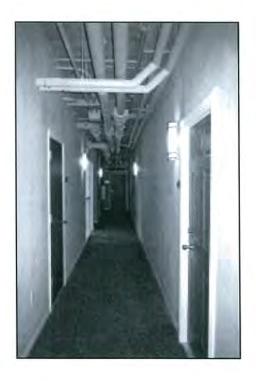
Left: The exposed pipes give the corridor, although quite plain, an unfinished appearance which is not compatible with the historic character of this 1926 bank building.

Application I (*Incompatible treatment*): The tangle of pipes along the corridor of this 1926 bank building, which was rehabilitated into apartments, creates a sharp visual distraction. Given the straightforward detailing of this corridor, installing a new ceiling to hide the overhead pipes would have been the preferred treatment, even if it meant lowering the original height of the ceiling. Where there is insufficient room in the corridor space to drop a new ceiling without significantly altering the volume of the space or interfering with existing features such as door transoms, trim, or other features, other solutions are required.

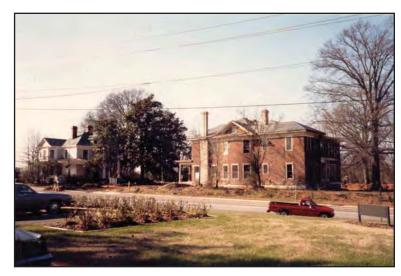
Turned 180 degrees, the moved building (B2) faces the historic one from a distance of 60 feet.

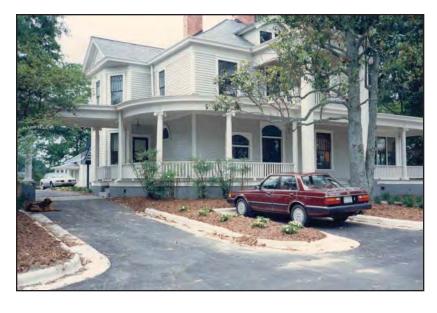
The new parking lot completes the drastic alteration of the setting. The second relocated structure (C2) can be seen through the porte-cochere at left.

ing. The central parking lot, has become a dominant new feature of the site. The historic building now appears as but one element in a new composition bearing little relationship to the historic appearance of the property. As a result, the historic character of the overall property has been greatly diminished, and the project does not meet the Standards.

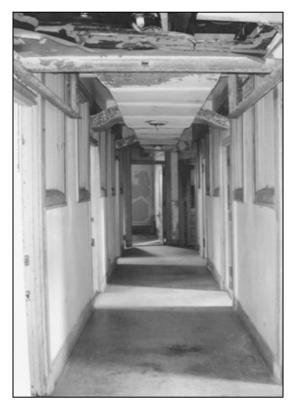
Above: The dropped ceiling has been partially removed, revealing the old ductwork running through the center of the hallway and branching into each office. The ceiling had been lowered from its historic height of 10 feet to just 7 feet.

network of ceiling distribution ducts. As a cost-cutting measure, the main distribution ducts were run along the corridors, below the existing ceiling, and branched off into the individual offices. Rather then cutting through the walls to add the necessary room vents, the vents were installed through the transoms above the office doors. The very low suspended ceiling that was added to conceal the ductwork also obscured the transoms and cut across the windows in the corridors. This dropped ceiling dramatically and negatively impacted the historic appearance of the corridors.

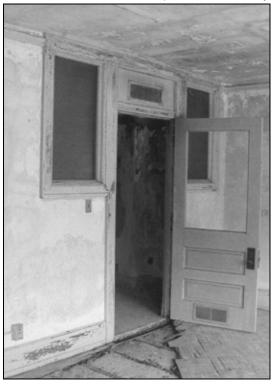
Above: Prior to rehabilitation the offices had air supplied through vents installed in the original door transoms.

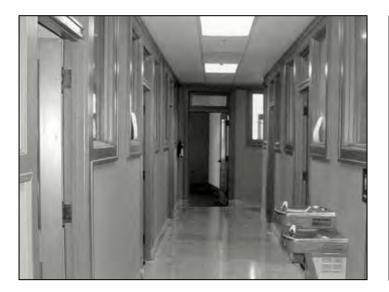
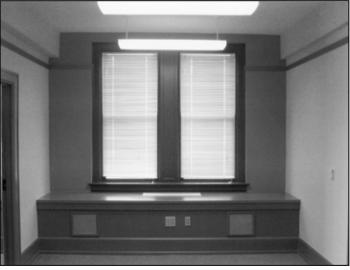
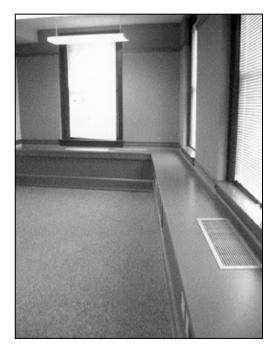
Top left: The rehabilitation raised the ceiling above the door transoms. This not only uncovered the historic, character-defining transoms, but also allows more natural light into the corridors.

Top right: The offices now have heating/cooling vents located in a window seat-like feature which also incorporates the original baseboard. Note the integrated electrical outlets and voice and data jacks on the front of this built-in feature.

and concealed in a new built-in feature that contained not only the air supply and return, but also included new electrical service and voice and data lines. The design for the new interior built-in feature drew on the appearance of the old window seat-styled radiator covers that were common in buildings of the era and even incorporated the original, historic baseboards in its design. This design provided for an unobtrusive and aesthetically pleasing appearance for the new built-in feature.

This treatment enabled the offices to retain their historic ceiling height. And, by removing the existing ductwork from the corridors, it was possible to significantly raise the corridor ceiling height, even though the corridor ceilings could not be raised to their full original height due to the sprinkler piping and lay-in light fixtures above. Removing the ductwork and raising the ceiling in the corridors also uncovered the door transoms and fully exposed the hallway windows. This HVAC installation not only recaptured the historic character of the corridors but also retained the character of the office spaces and, therefore, meets the Standards for Rehabilitation.

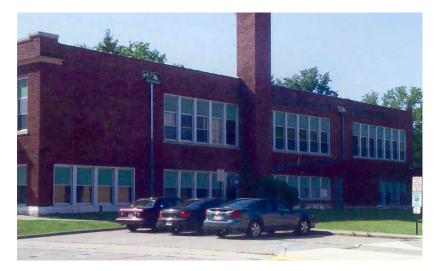
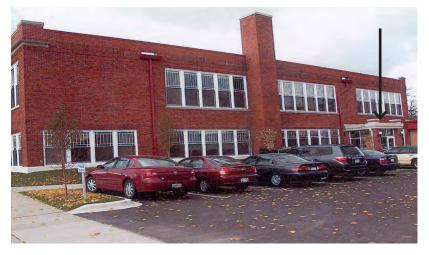
Top: Rear façade of school prior to rehabilitation.

Middle: Rear façade after rehabilitation. New accessible entrance is located on the far right. Bottom: New accessible entrance. The same brick and limestone were used for the addition, while contemporary-styled windows and doors help to differentiate the new construction.

Application 2 (*Compatible treatment*): Built in 1922, this school building was rehabilitated for office use. Due to interior level changes and the absence of an elevator, an accessible entry was required. A small grade-level entrance was added to the rear of the building. The one-story addition relates to the historic building through its use of brick and limestone detailing. The addition is clearly differentiated through its use of modern window and door openings. By placing the addition on the rear, the symmetrical main façade remains unchanged. The new entrance leads to a newly configured lobby with access to a new elevator. The new rear addition is compatible with the historic building and meets the Standards.

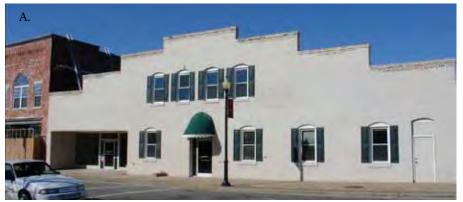
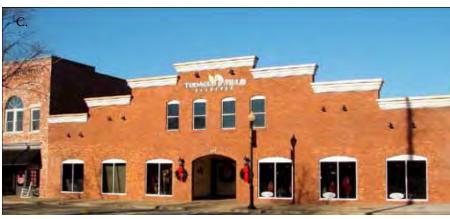
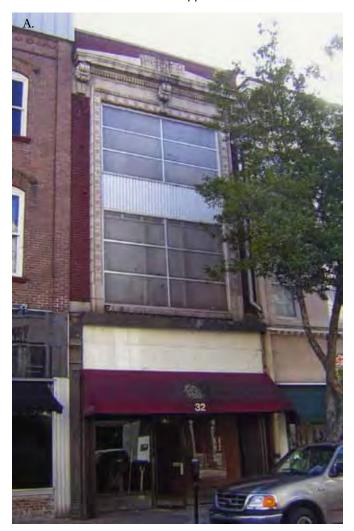
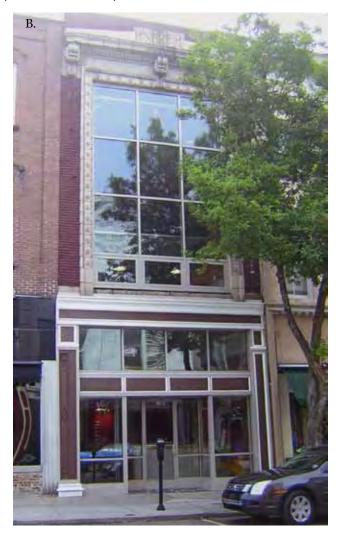
Clockwise from top left:

- A. The primary elevation of the ground floor of this historic warehouse, which had been altered prior to rehabilitation, featured double-hung windows, two pedestrian doors and a recessed storefront.
- B. Historically, the warehouse space was accessed from the side via large arched loading bays.
- C. During rehabilitation, the original arched masonry openings on the side of the building were replicated on the front and a heavy cornice was also added to the parapet. These treatments resulted in a false sense of the historic appearance of the building.

Application 1 (*Incompatible treatment*): This early-twentieth century tobacco and cotton warehouse is sited on the main commercial street in a historic district. Prior to rehabilitation the front of the building featured one-over-one windows, two pedestrian doors and an incompatible recessed storefront that had been added in the mid-twentieth century. Original large, arched openings on a side elevation that had provided access to the warehouse area were still extant. When the warehouse was rehabilitated for retail use, one of the objectives was to create large display windows on the primary elevation. The owner chose to base the design of these new shop windows on the historic arched openings located on the side of the building. The front was further changed by the addition of a heavy new cornice to the stepped parapet. These conjectural changes—the new arched openings and the large cornice—diminish the historic utilitarian character of the property and convey a false sense of historicism. This project does not meet the Standards.
